MEMORANDUM

DATE: January 19, 2024
TO: Mark Chow, County of San Mateo
FROM: Ben Shick, PE
SUBJECT: Crystal Springs County Sanitation District – Pipe
and Manhole Assessment and Recommendations

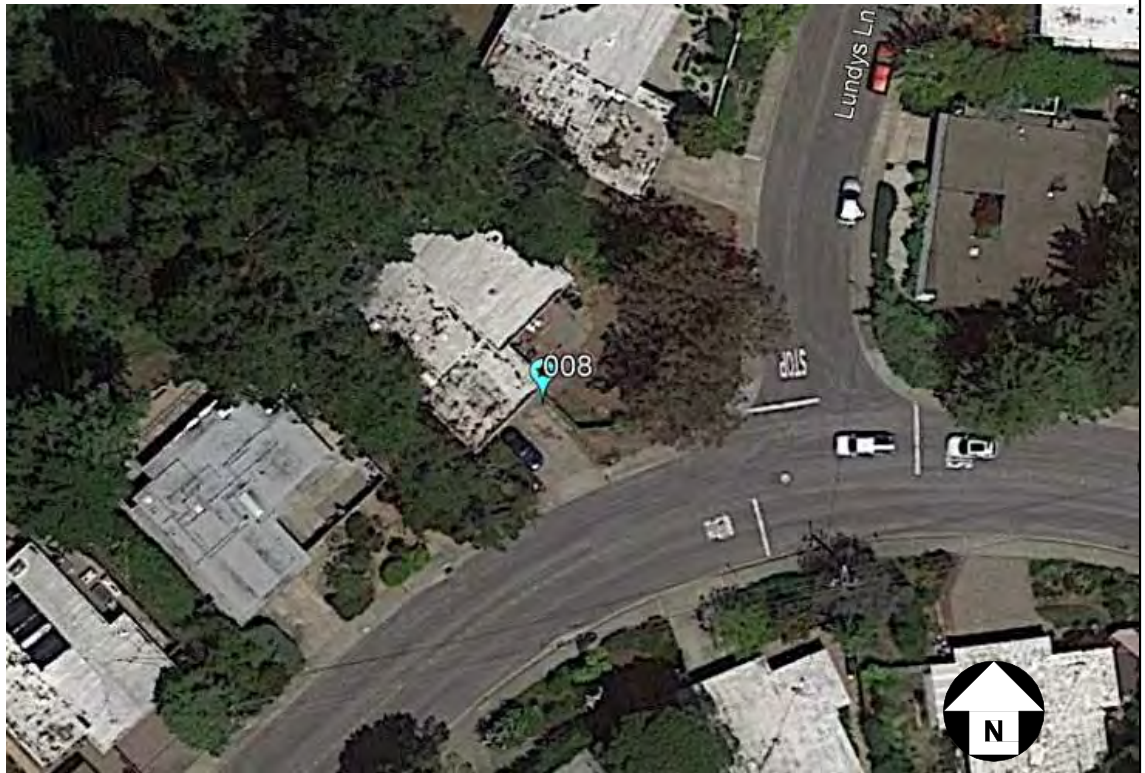
Comments: No Cap

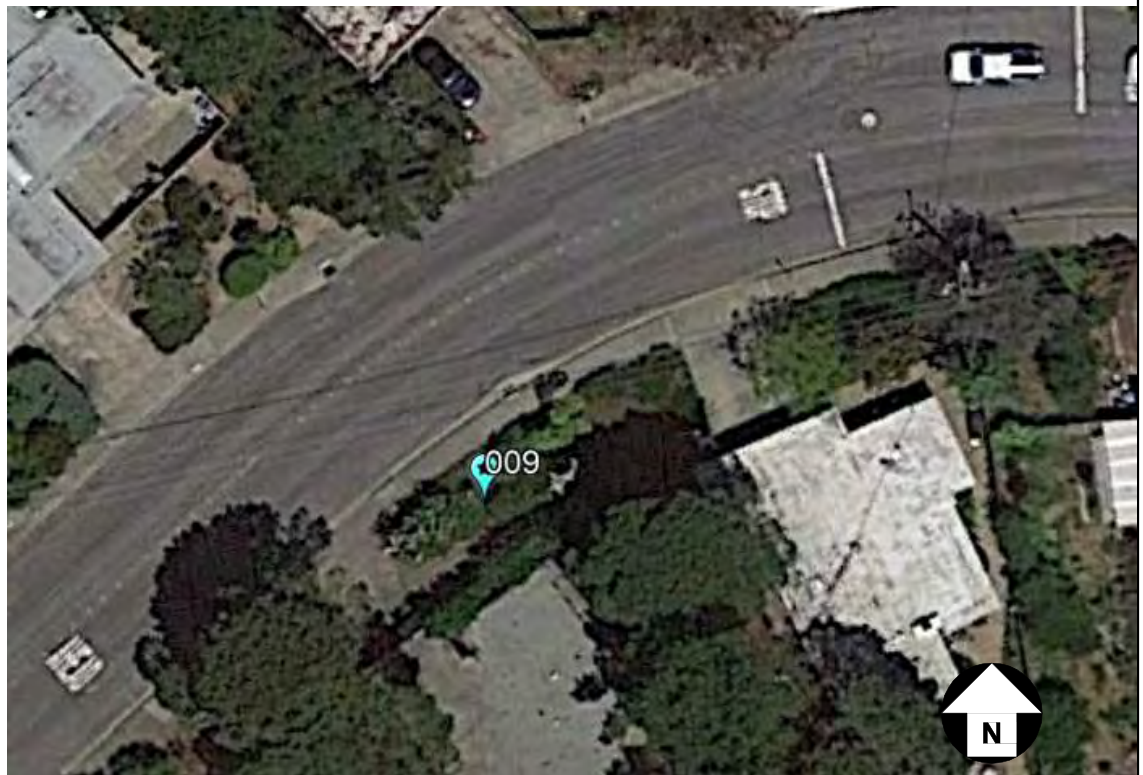
Comments: Could be burried cleanout but could not locate

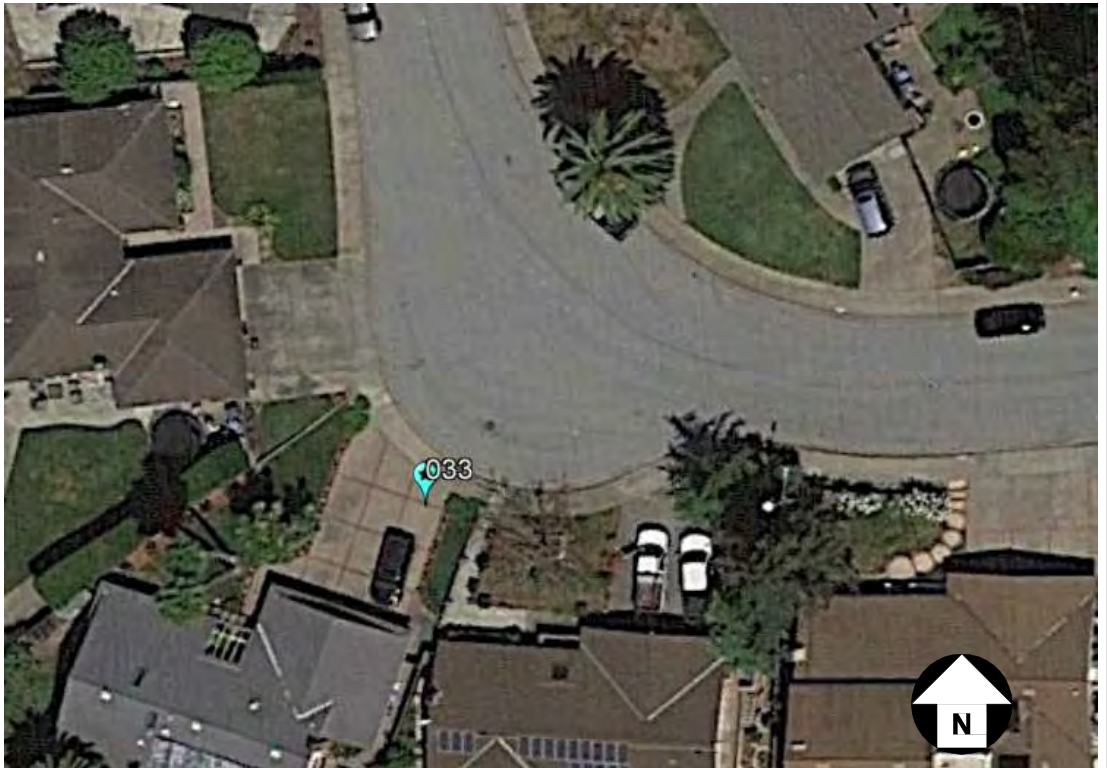
Comments: Rusty/Deteriorated Cap

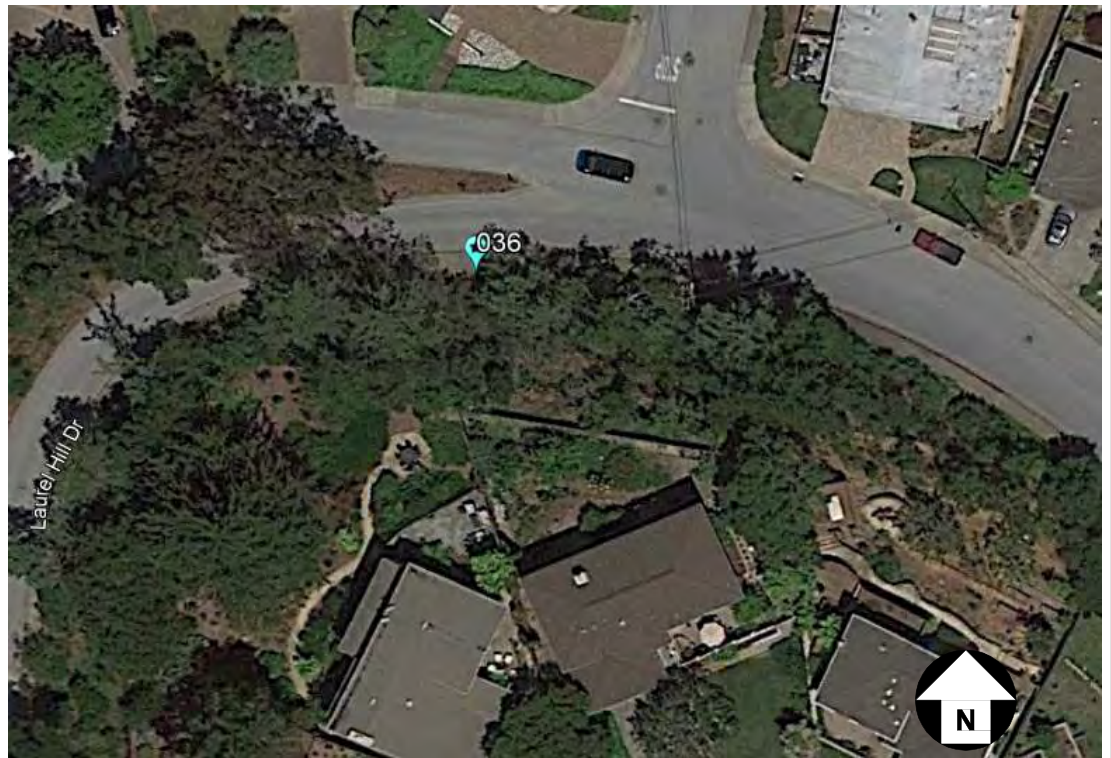
Comments: Missing cap; low spot; Backside of property

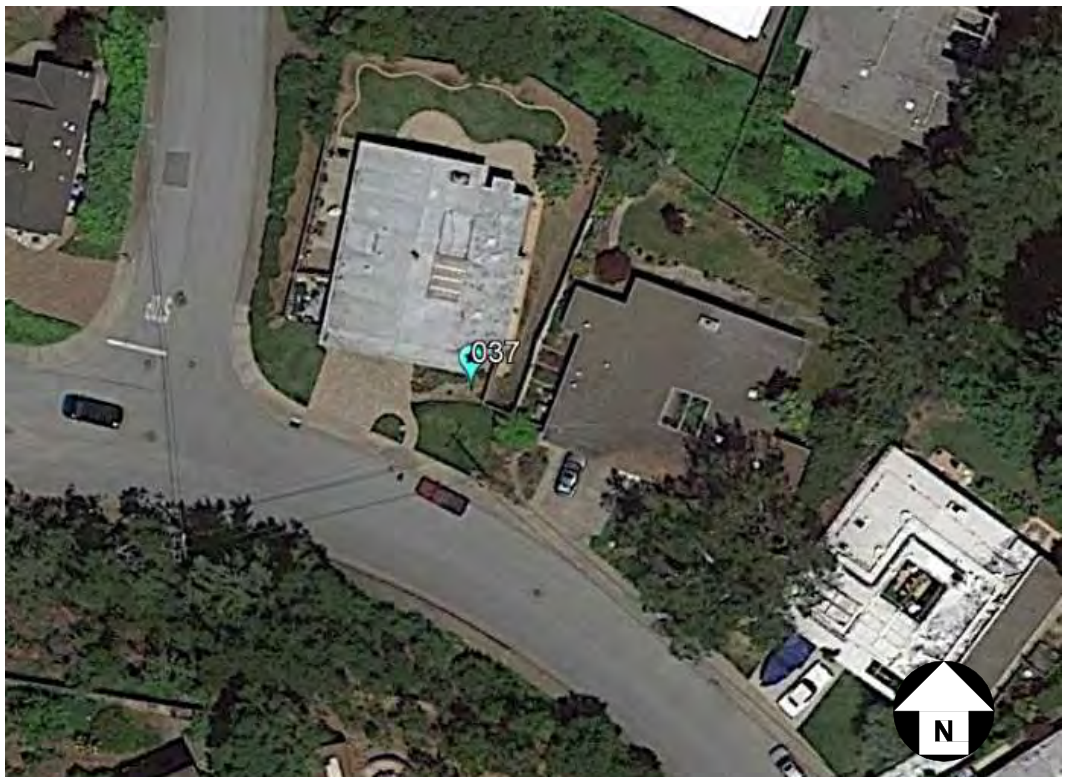
Comments: Missing cap; low spot;

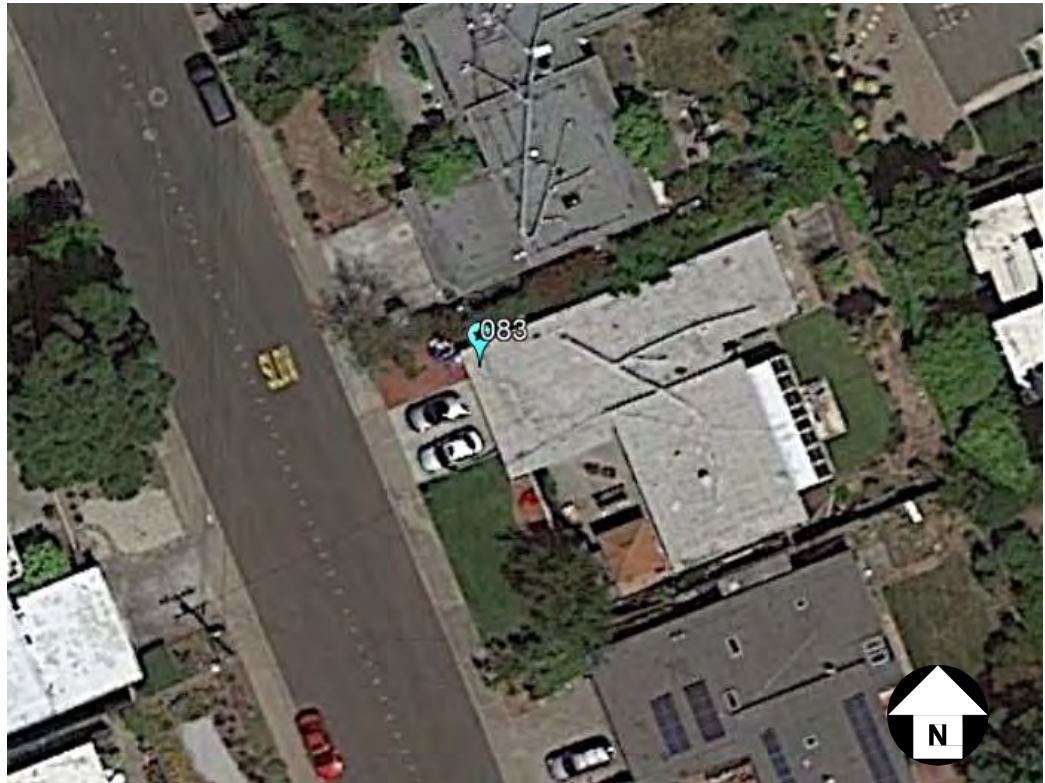
Comments: Main area drain of entire driveway and gutters also drain here

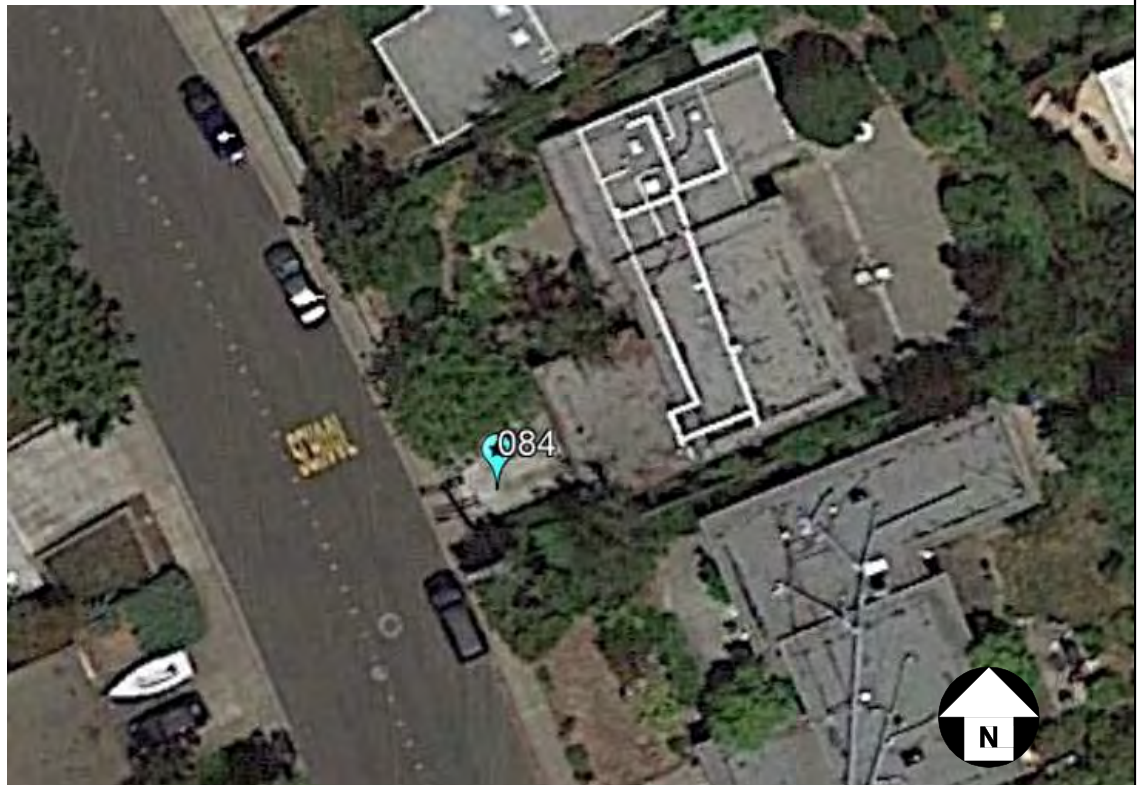
Comments: Not lowest point but does funnel here through pavement groove. Gutter also drain here

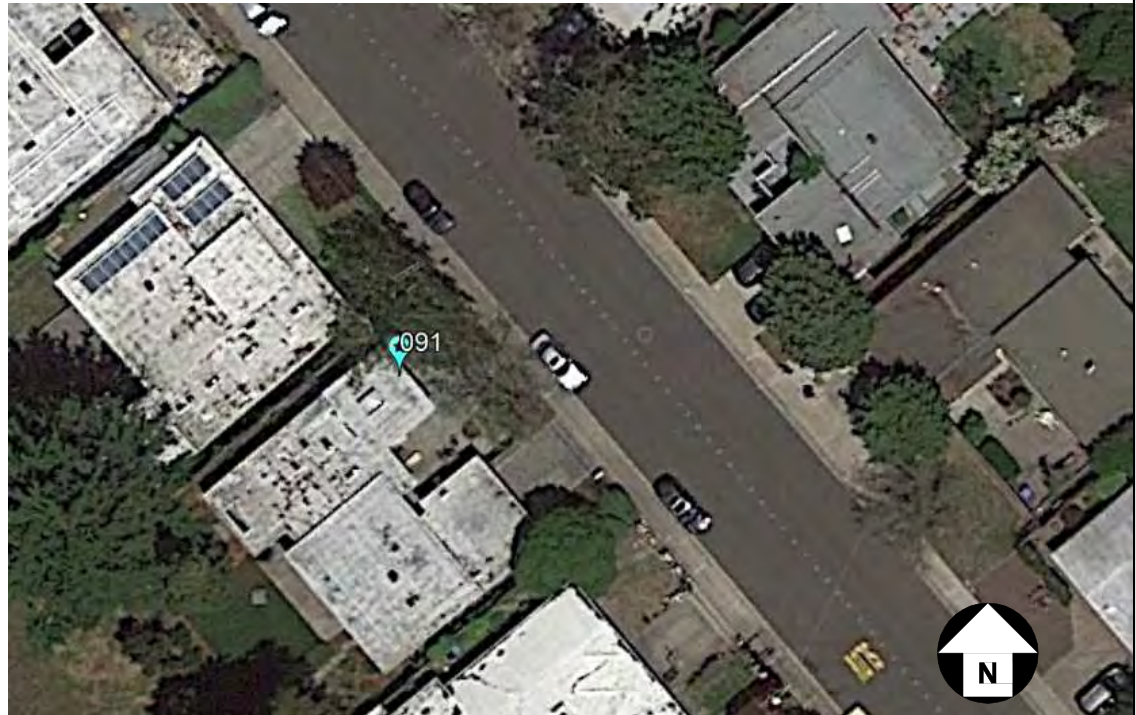
Comments: Area drain or lateral

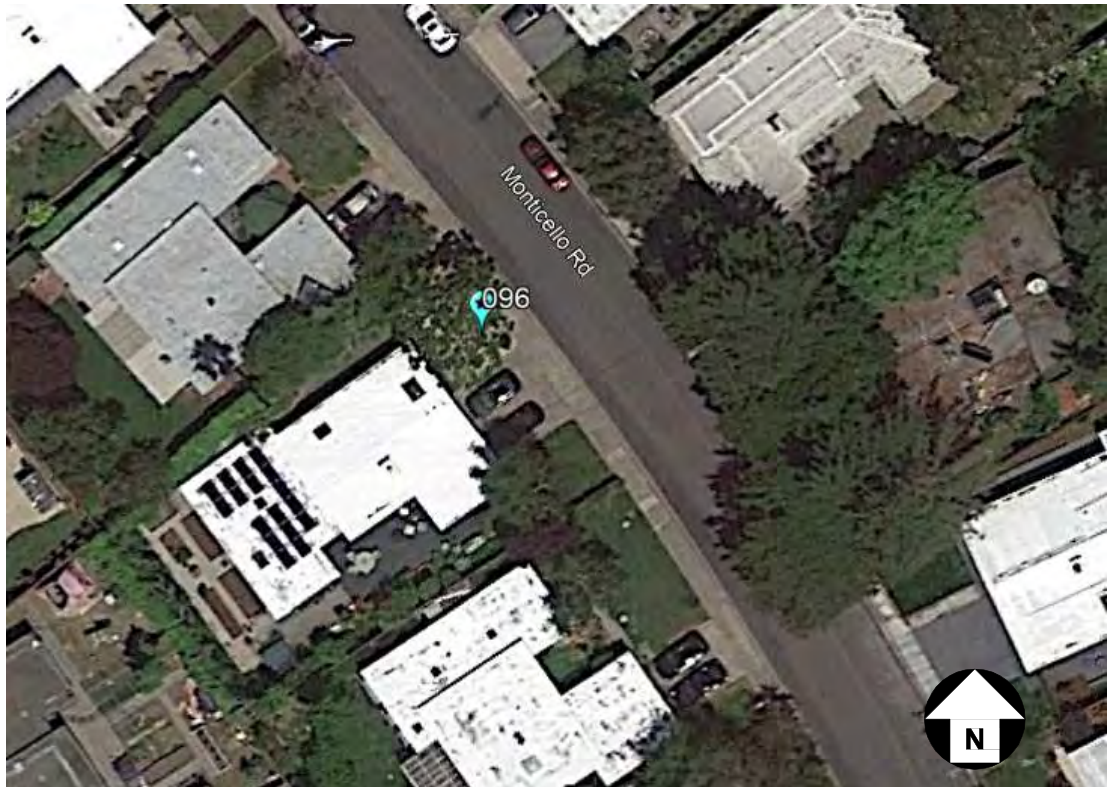
Comments: Rusty/Deteriorated Cap. Low point

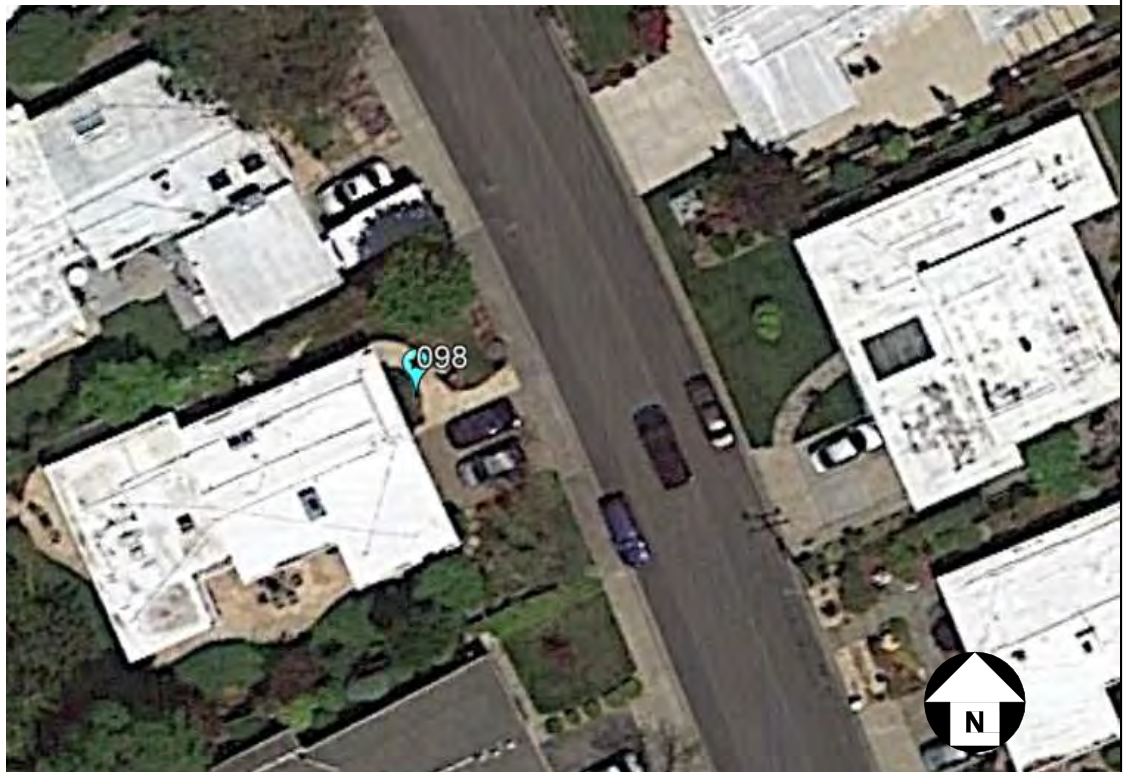
Comments: Cleanout could not be located. Low point near walkway

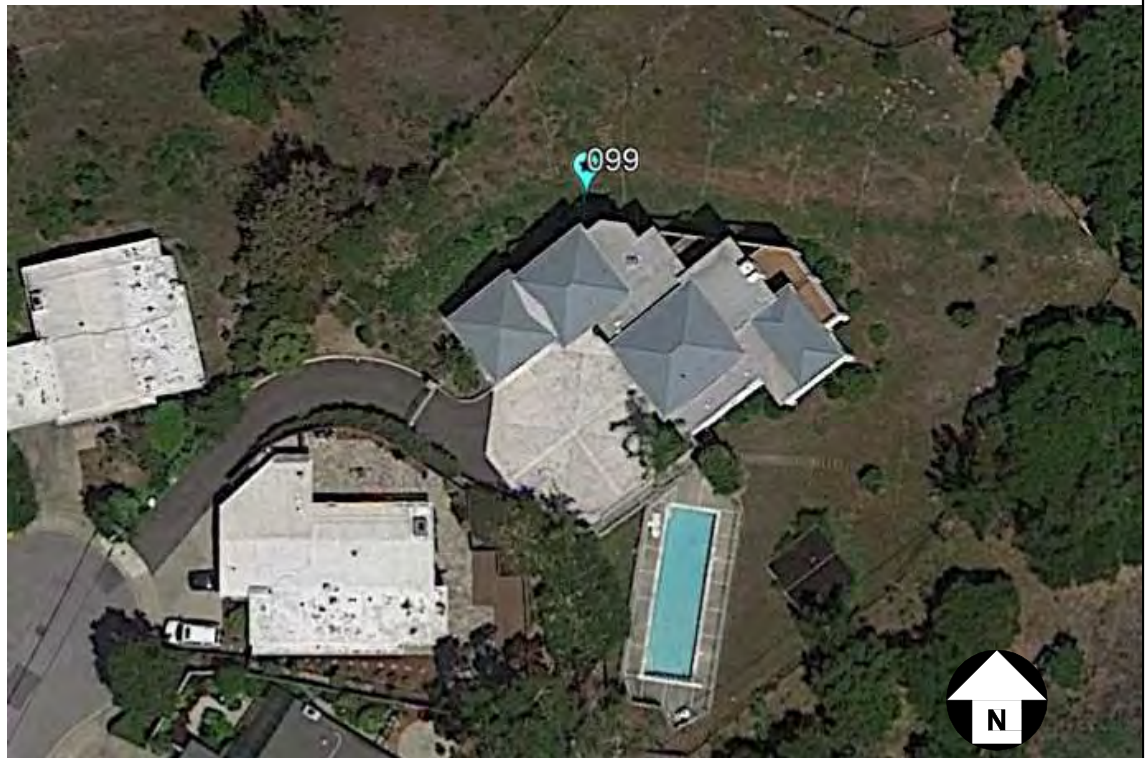
Comments: Sewer manhole lid low point on hill; infiltration disk recommended

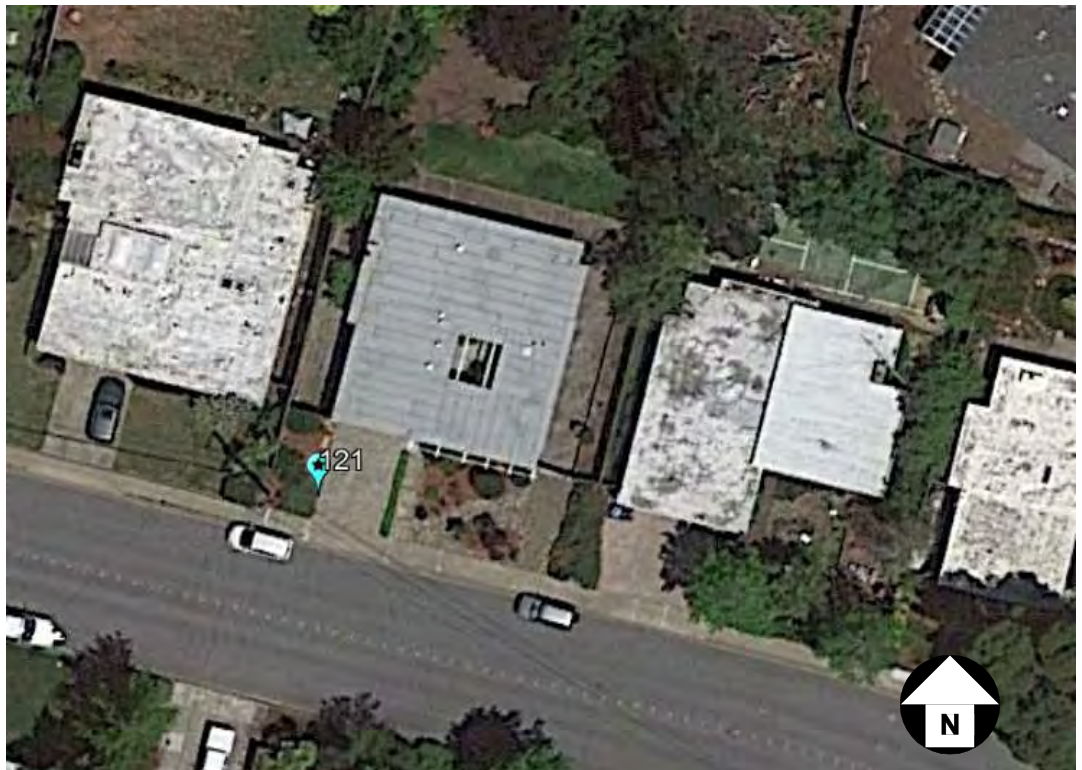
Comments: No cleanout present. Most likely lateral

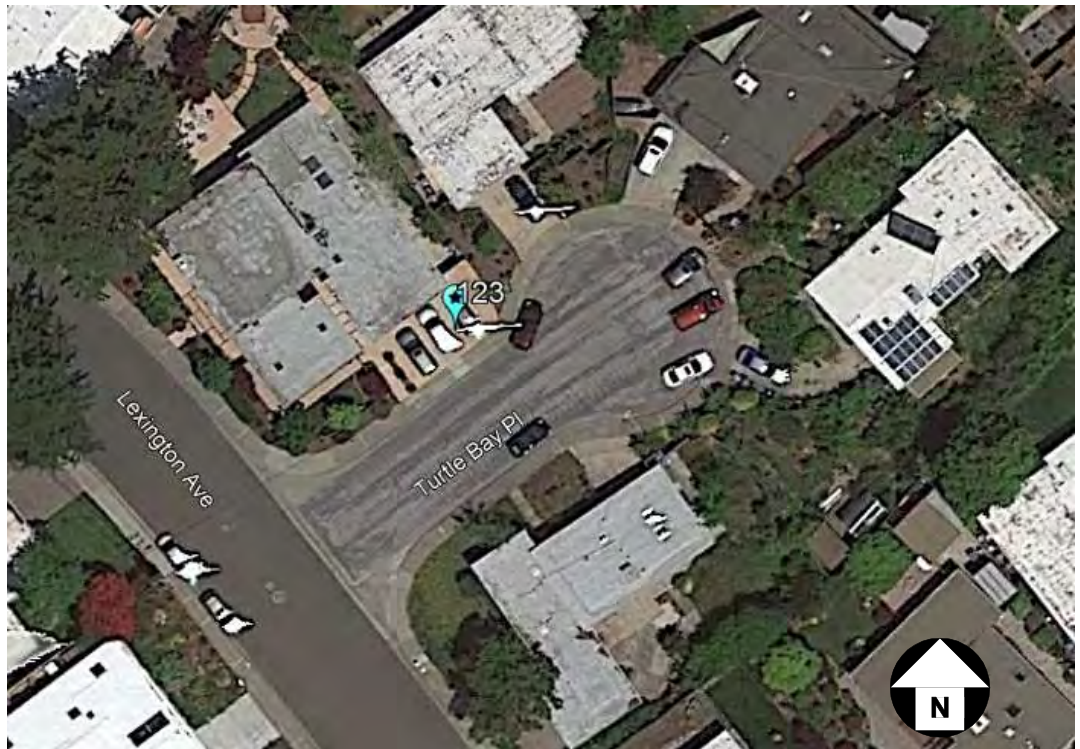
Comments: No cap.

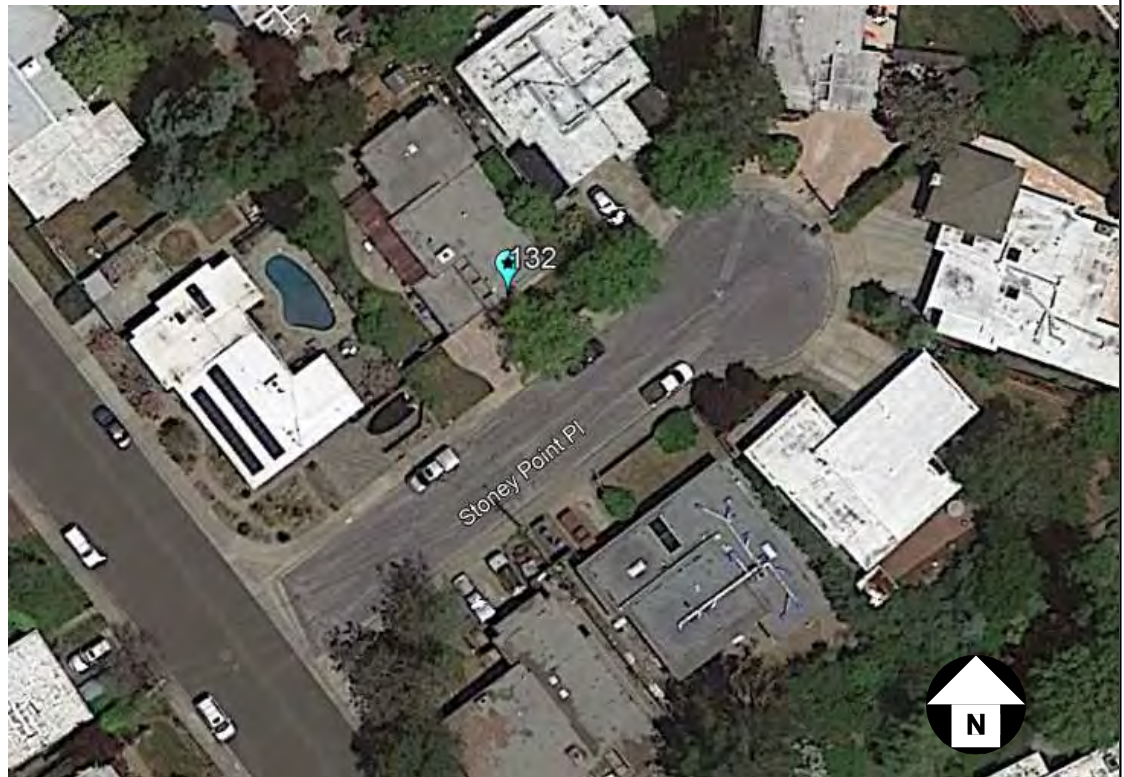
Comments: Cannot access due to debris. Most likely cleanout.

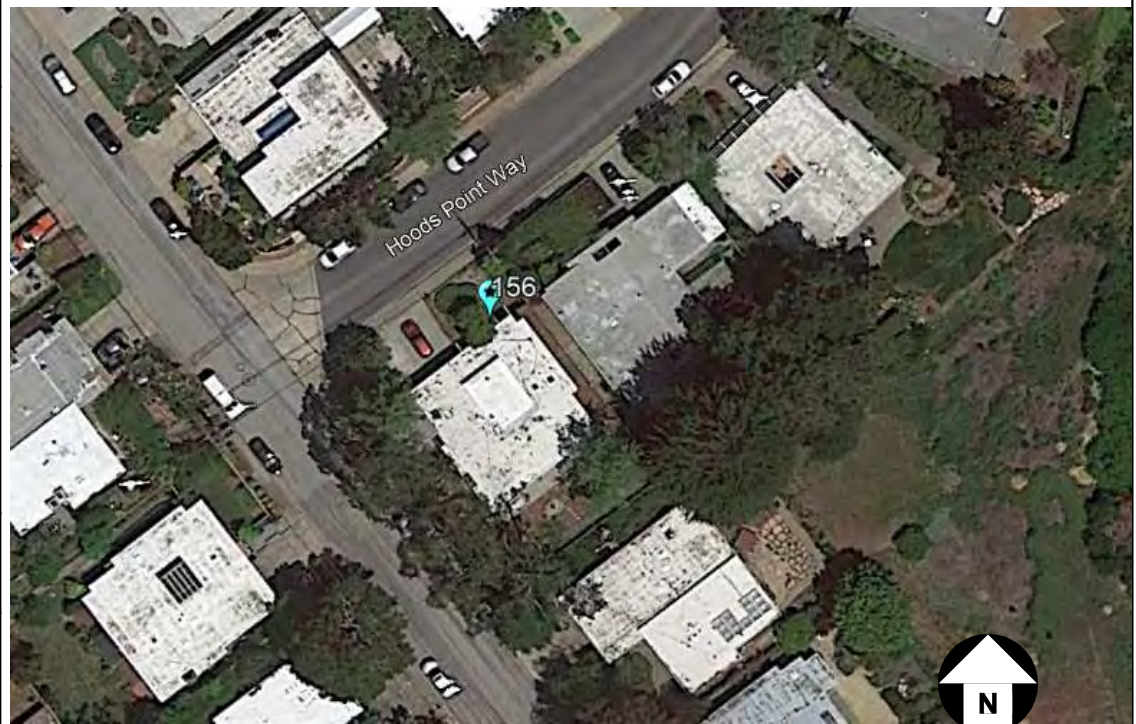
Comments: Low point. No cap

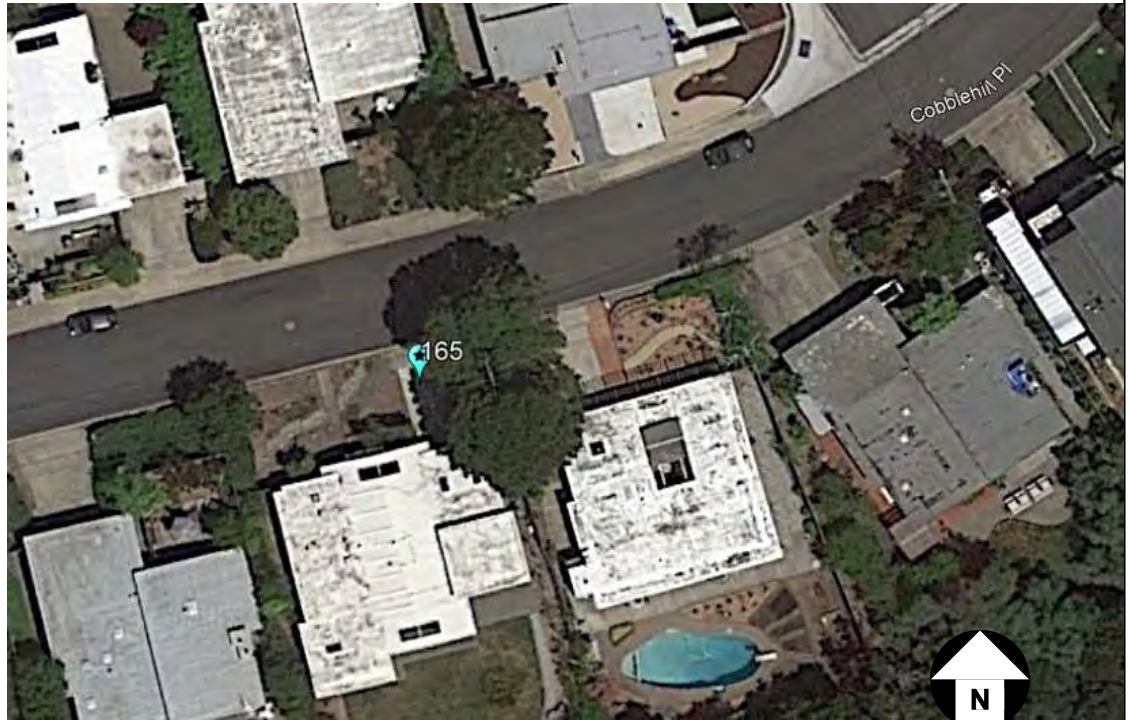
Comments: Cap loose. Water flows over top.
