MEMORANDUM

DATE: January 19, 2024
TO: Mark Chow, County of San Mateo
FROM: Ben Shick, PE
SUBJECT: Crystal Springs County Sanitation District – Pipe
and Manhole Assessment and Recommendations

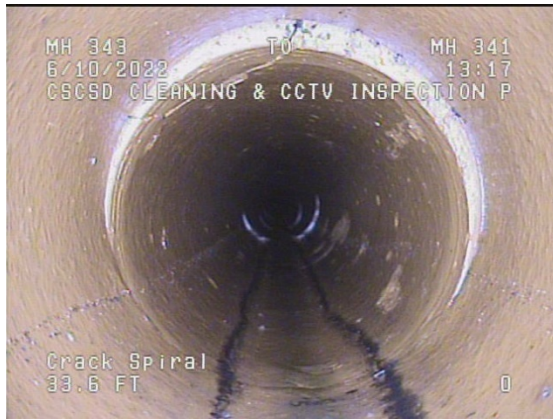
Example 1: Spiral Crack

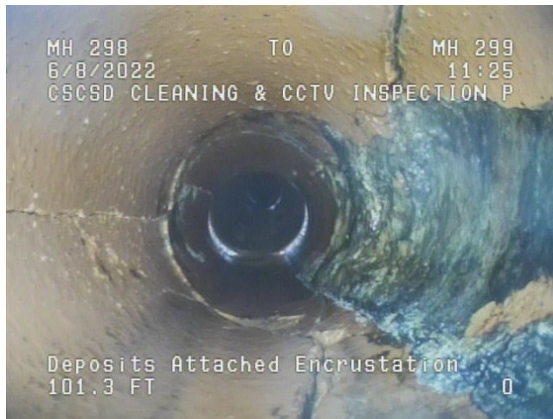
Example 3: Encrustation Deposits/Infiltration Stain

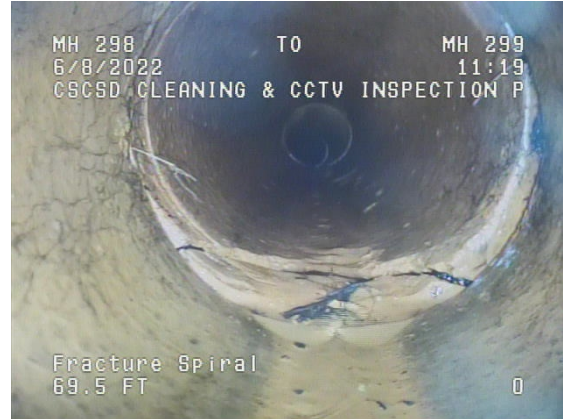
Example 4: Spiral Crack

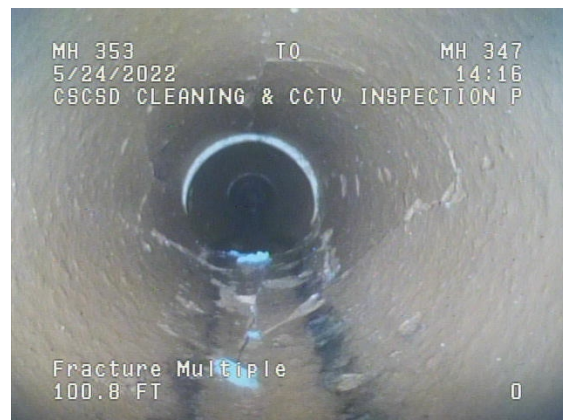
Example 6: Multiple Fractures

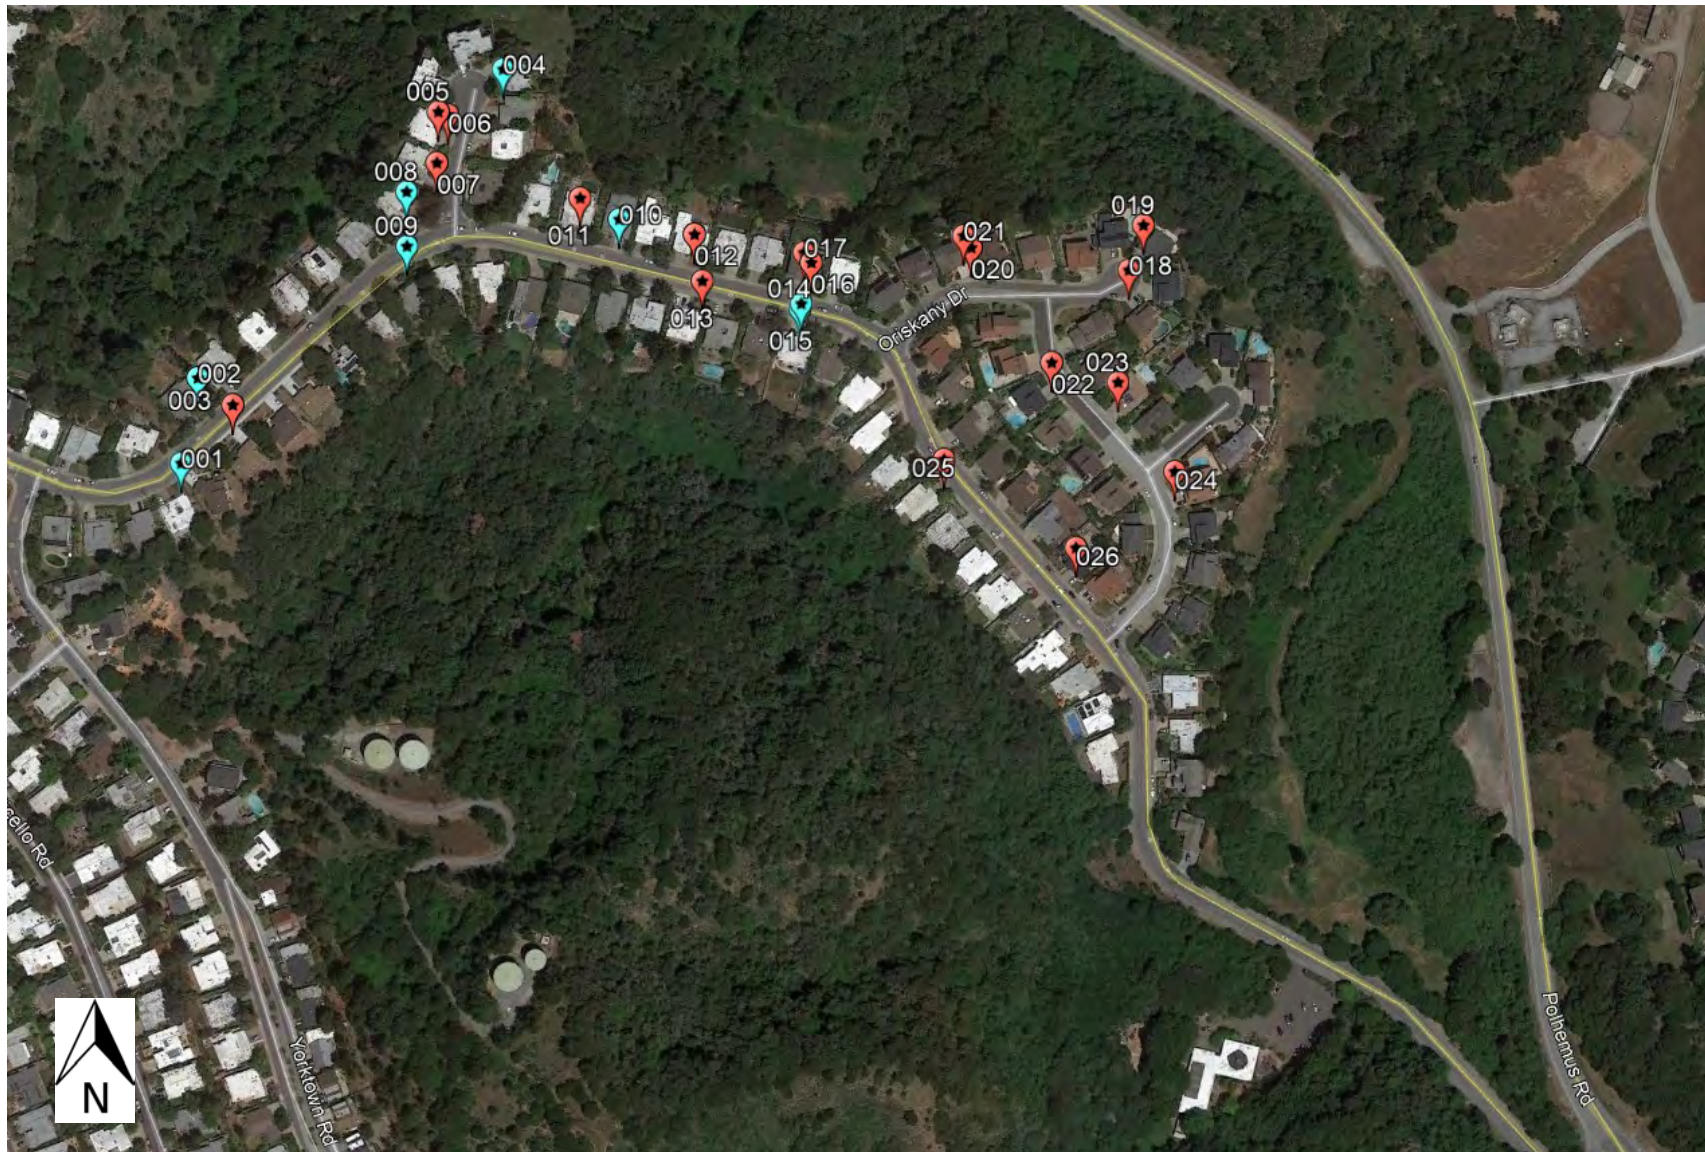
Figure 4: Basin CS-10 Area Defects
(Blue star: Smoke testing form pages 1 & 2 completed. Red star: Standard cleanout. Smoke testing form page 2 completed)
