***Peter's Creek Crossing and
Trail Improvements
Geotechnical Investigation***

November 22, 2019

Peters Creek Crossing Geotechnical Investigation Report

Questa Project Number 1900028

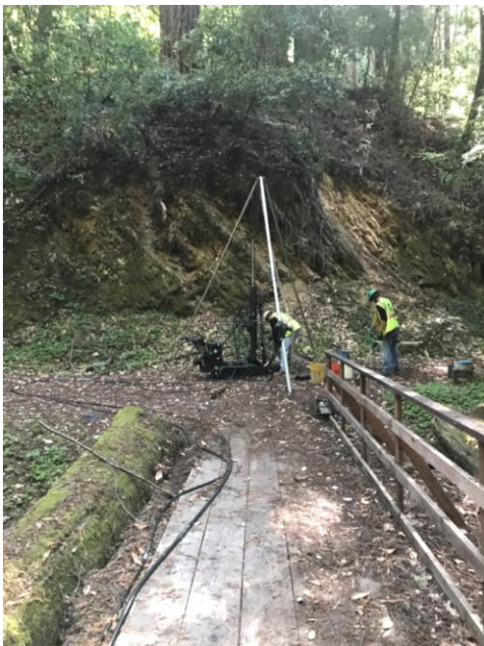
Photograph 1. B-1, east of bridge, drilled with a portable rig

Boreholes B-1 and B-2, were drilled 10' east and west, respectively, of the existing bridge, as shown on **Figure 1**, and the **Pictures 1** and **2** displayed below. Due to limited accessibility, borehole B-1 was drilled with an A-frame portable drilling set-up, while Borehole B-2 was drilled with a Simco 2400 SK-1.

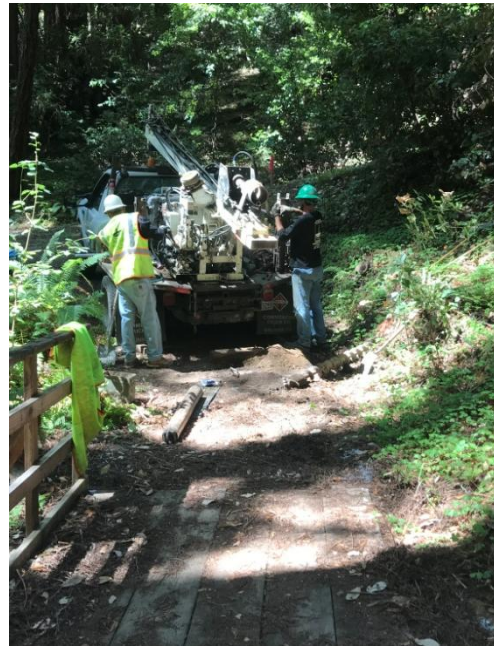
Photograph 2. B-2, west of bridge, drilled with Simco 2400 SK-1

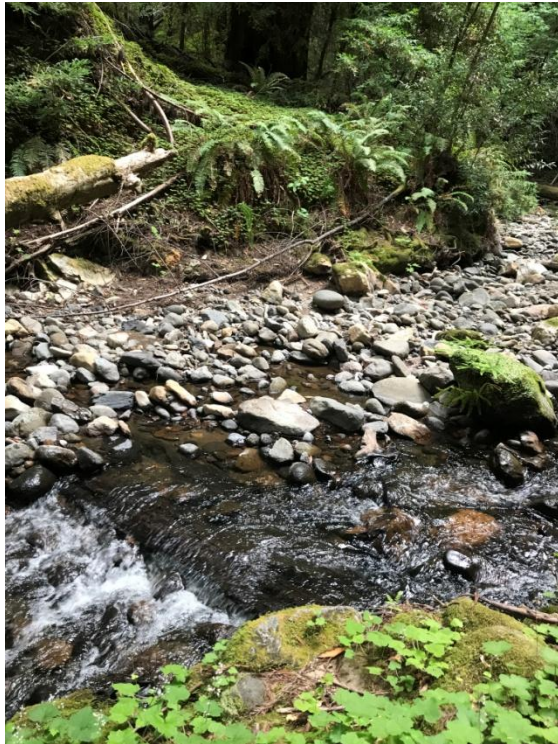
Photograph 3. Bedrock exposed in channel bed near proposed Bridge Crossing 1.

Bedrock outcrops surrounding the site have been mapped as part of the Middle Miocene Monterey Formation, a medium to thick bedded laminated olive-gray bio-siliceous, organic rich mudstone and sandy siltstone deposit.³ Bedrock is present in the creek channel in both of the proposed bridge locations as seen in Photographs 1 and 2 below.

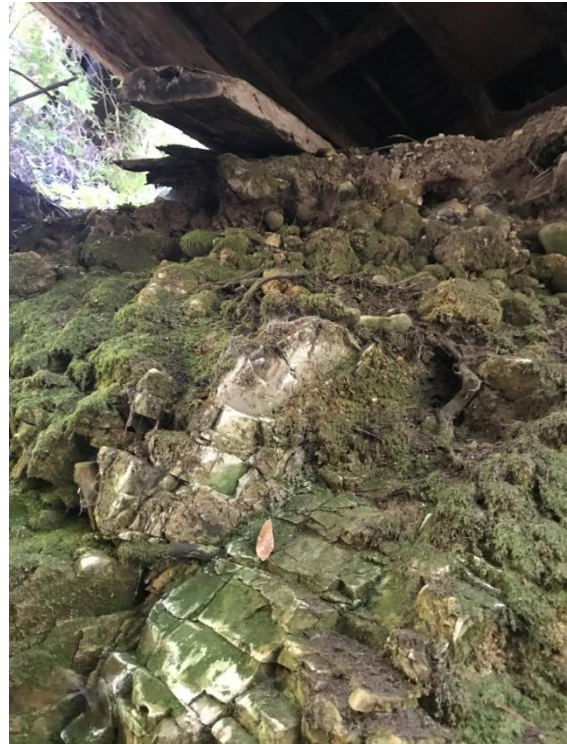
Photograph 4. Bedrock exposed beneath existing bridge at proposed Bridge Crossing 2.

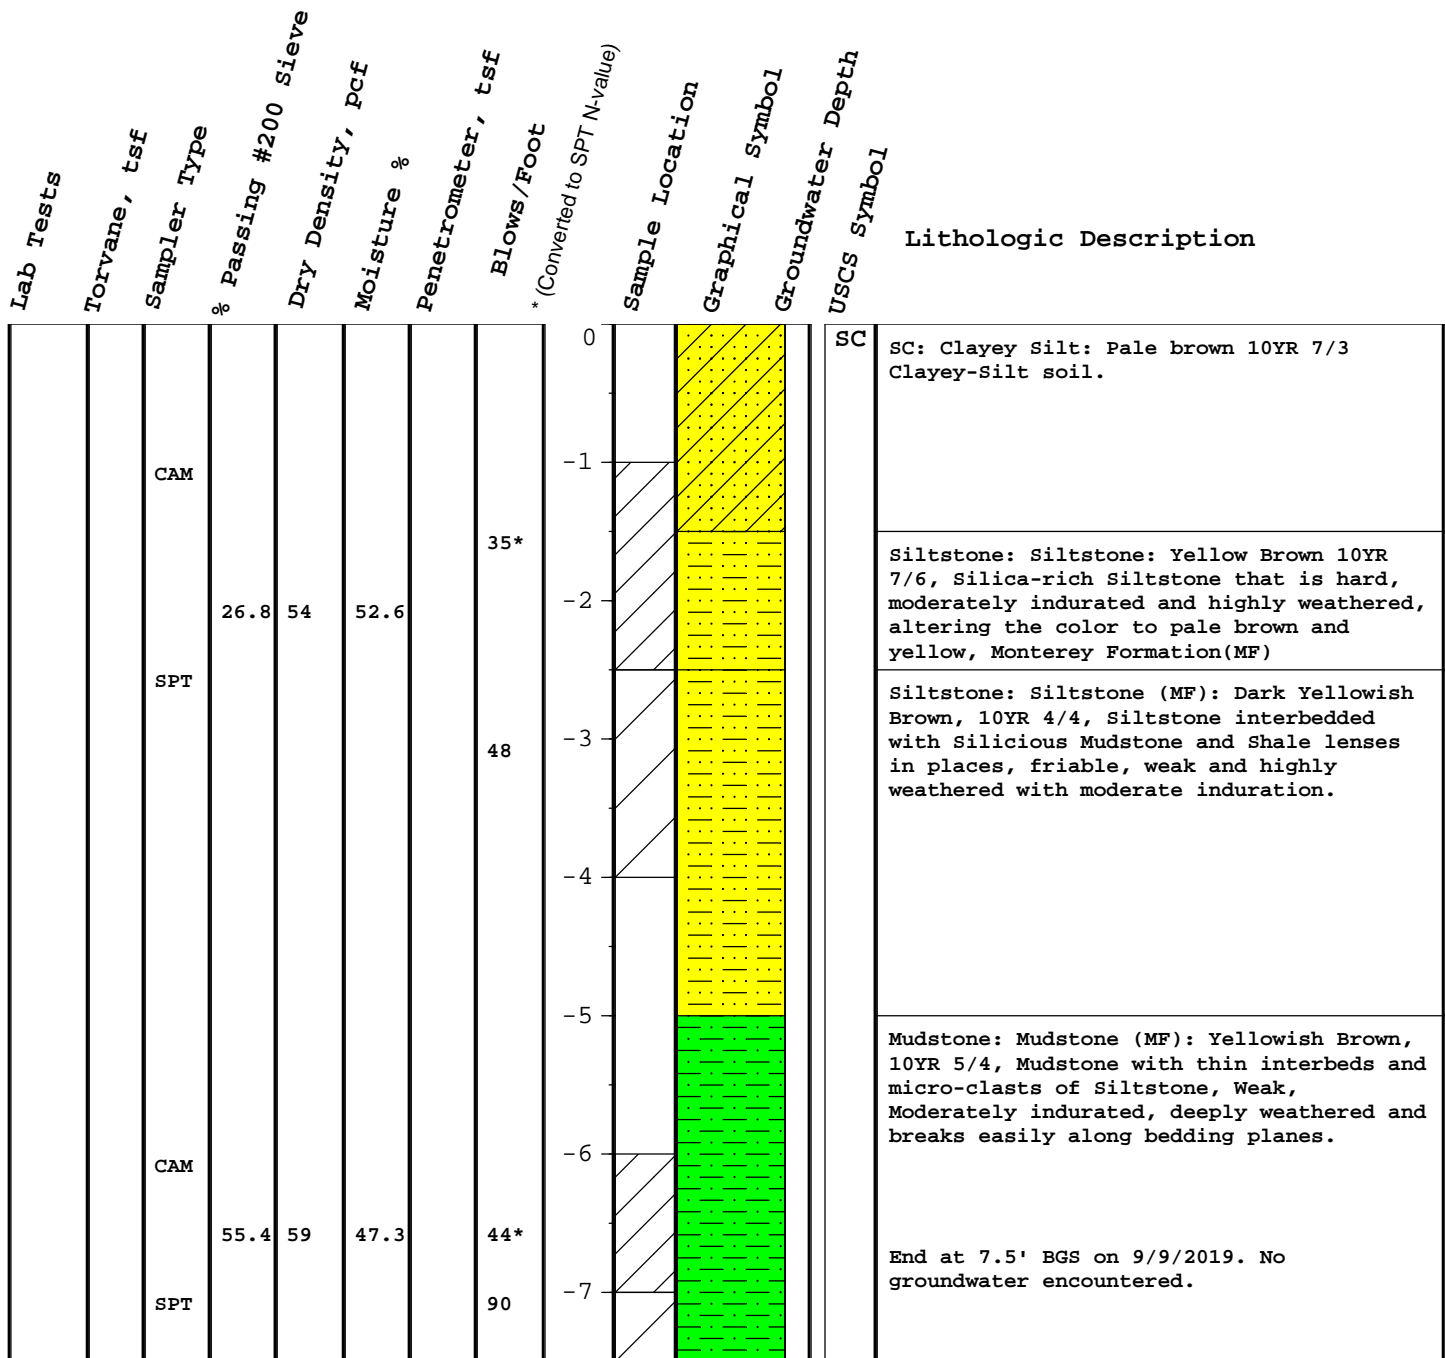
*Sampling was performed by Denovo Drilling using a hydraulic portable drill rig equipped with solid flight augers.

<p>Civil Environmental & Water Resources</p> <p>QUESTA ENGINEERING CORP</p> <p>1510 236-4114 FAX: 1510 236-2423 QUESTA@QUESTA-ENG.COM</p> <p>P.O. Box 70356 1220 Brickyard Cove Road Point Richmond, CA 94807</p>	<p>LOG OF BOREHOLEB-1 Portola Redwoods Bridge La Honda, CA</p>	<p>Figure 4</p>
--	---	-----------------------------------

Locations of the boreholes are presented on **Figure 1**. The logs of boreholes are presented as **Figures 4** and **Figure 5**. Soils were logged in accordance with the Unified Soil Classification System (ASTM D 2487), which is summarized on **Figure 6**. Rocks were logged according to the Physical Properties Criteria for Description of Bedrock that is presented as **Figure 7**. Soil and rock colors were determined by use of a Munsell Soil Color Chart.

Borehole B-1 (**Figure 4**) penetrated medium dense clayey sand to a depth of 1.5 feet below ground surface (BGS), underlain by yellow brown siltstone from 1.5 feet BGS to 2.5 feet and dark yellow brown siliceous siltstone from 2.5 to 5 feet BGS. From 5 feet BGS to the bottom of the borehole at 7.5 feet BGS, yellowish brown siliceous mudstone with thin interbedded siltstone was encountered.

Moisture content and dry density testing were performed on selected soil samples to characterize the moisture content and dry density of material throughout the soil column. Testing was performed in accordance with ASTM 2937. In this test, the dry density of the soil is determined by a mathematical relationship between moisture content and wet density of the soil sample. Results of moisture-density testing are summarized on the borehole logs (**Figures 4 and 5**).

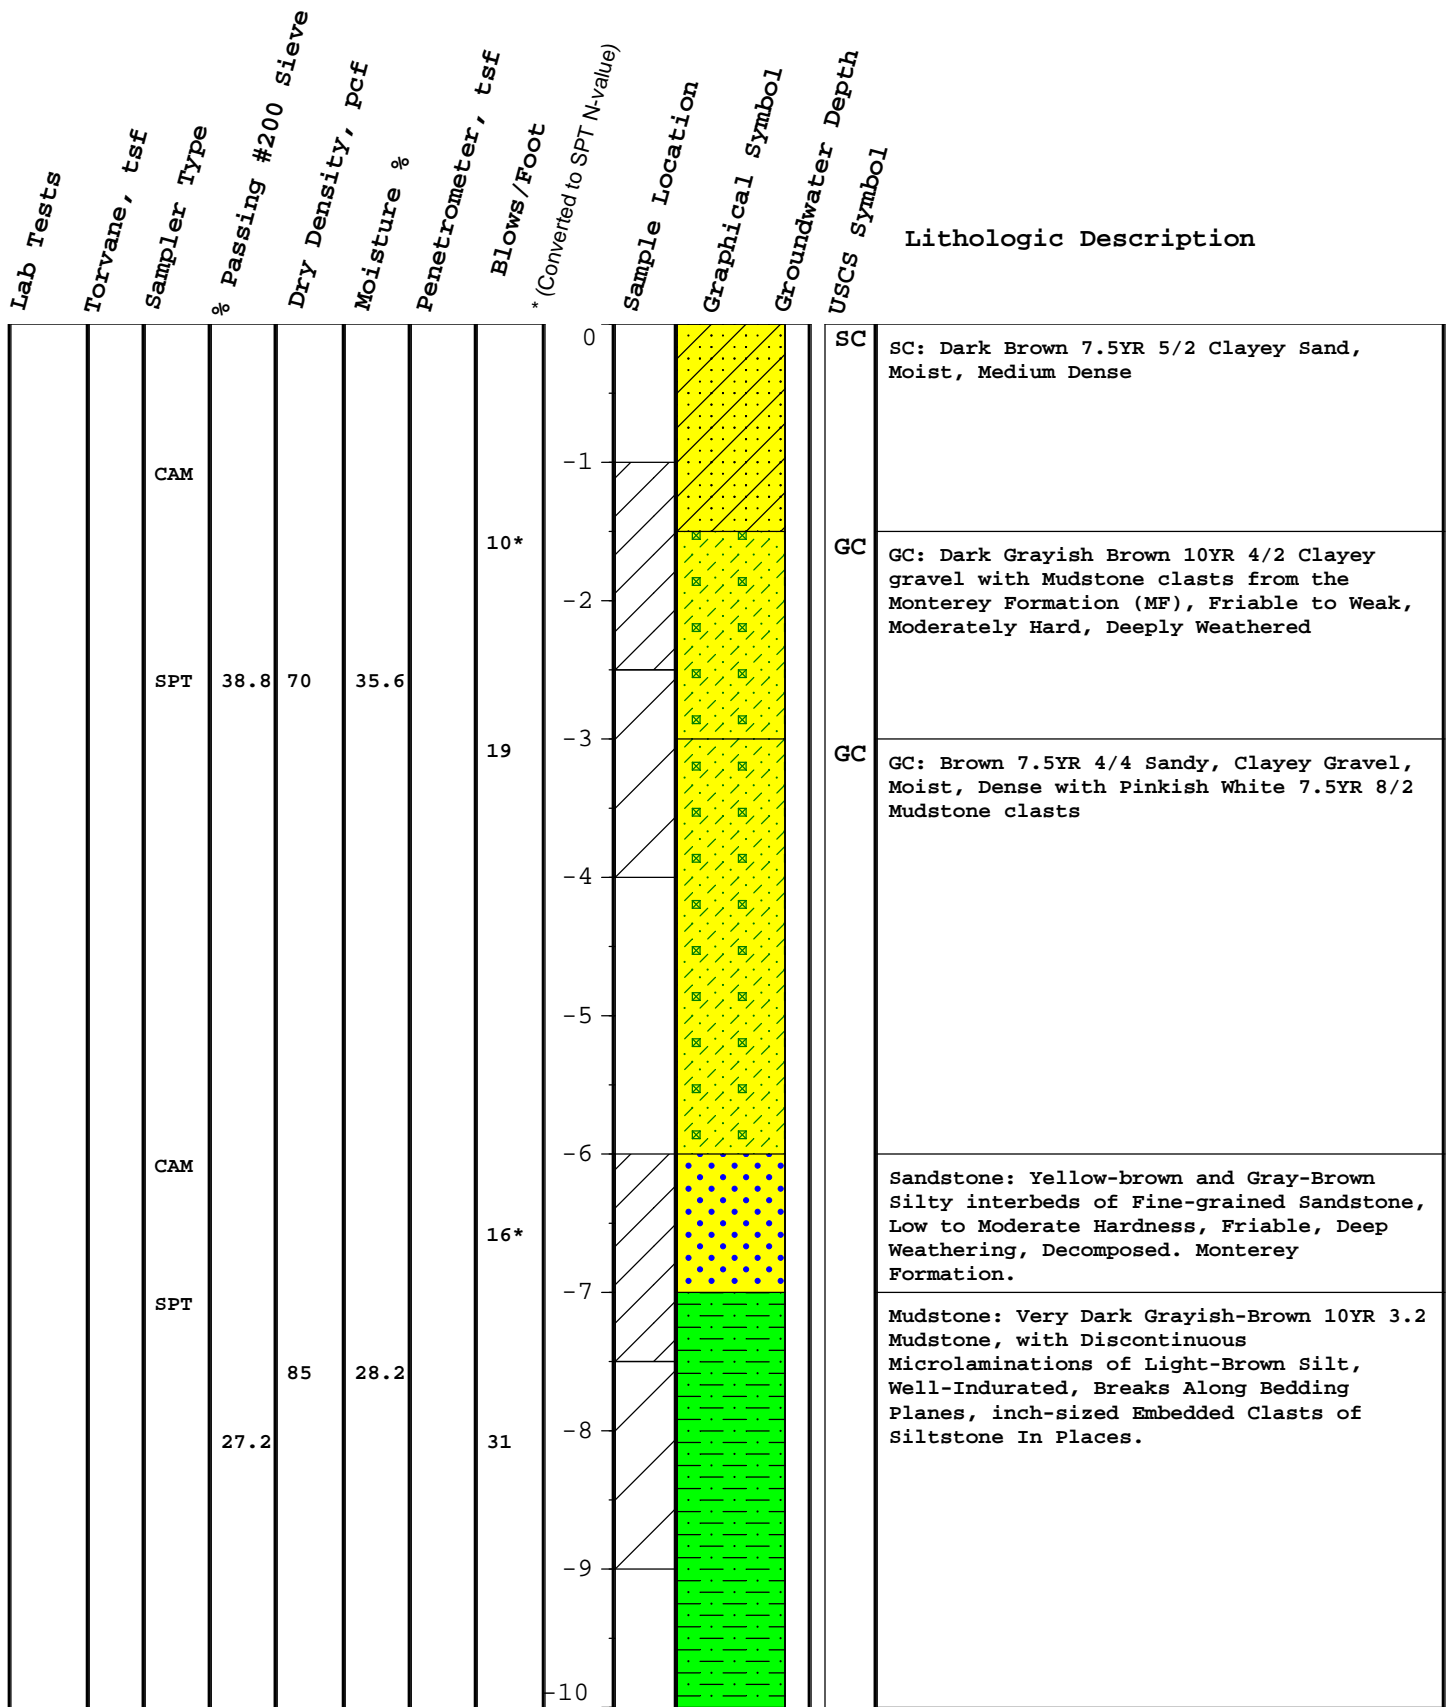
*Sampling was performed by Denovo Drilling using a hydraulic portable drill rig equipped with solid flight augers.

<p>Civil Environmental & Water Resources</p> <p>1510 236-4114 FAX 1510 236-2423 QUESTAENGINEERING.COM</p> <p>P.O. Box 70356 1220 Brickyard Cove Road Point Richmond, CA 94807</p>	<p>LOG OF BOREHOLEB-2 Portola Redwoods Bridge La Honda, CA</p>	<p>Figure 5</p>
--	---	-----------------------------------

Borehole B-2 (**Figure 5**) penetrated dark brown clayey sand from the ground surface to a depth of 1.5 feet BGS. From 1.5 to 3.0 feet BGS, dark grayish brown clayey gravel with mudstone clasts was encountered. From 3.0 to 6.0 feet BGS, brown sandy, clayey gravel with pinkish white mudstone clasts was encountered. From 6.0 feet to 7.0 feet, fine-grained sandstone was found. From 7.0 feet BGS to 12.5 feet BGS very dark grayish-brown mudstone was penetrated. Black siliceous shale was found from 12 to 12.5 feet BGS and was underlain by very dark grayish brown mudstone to the bottom of the hole at 20 feet BGS.

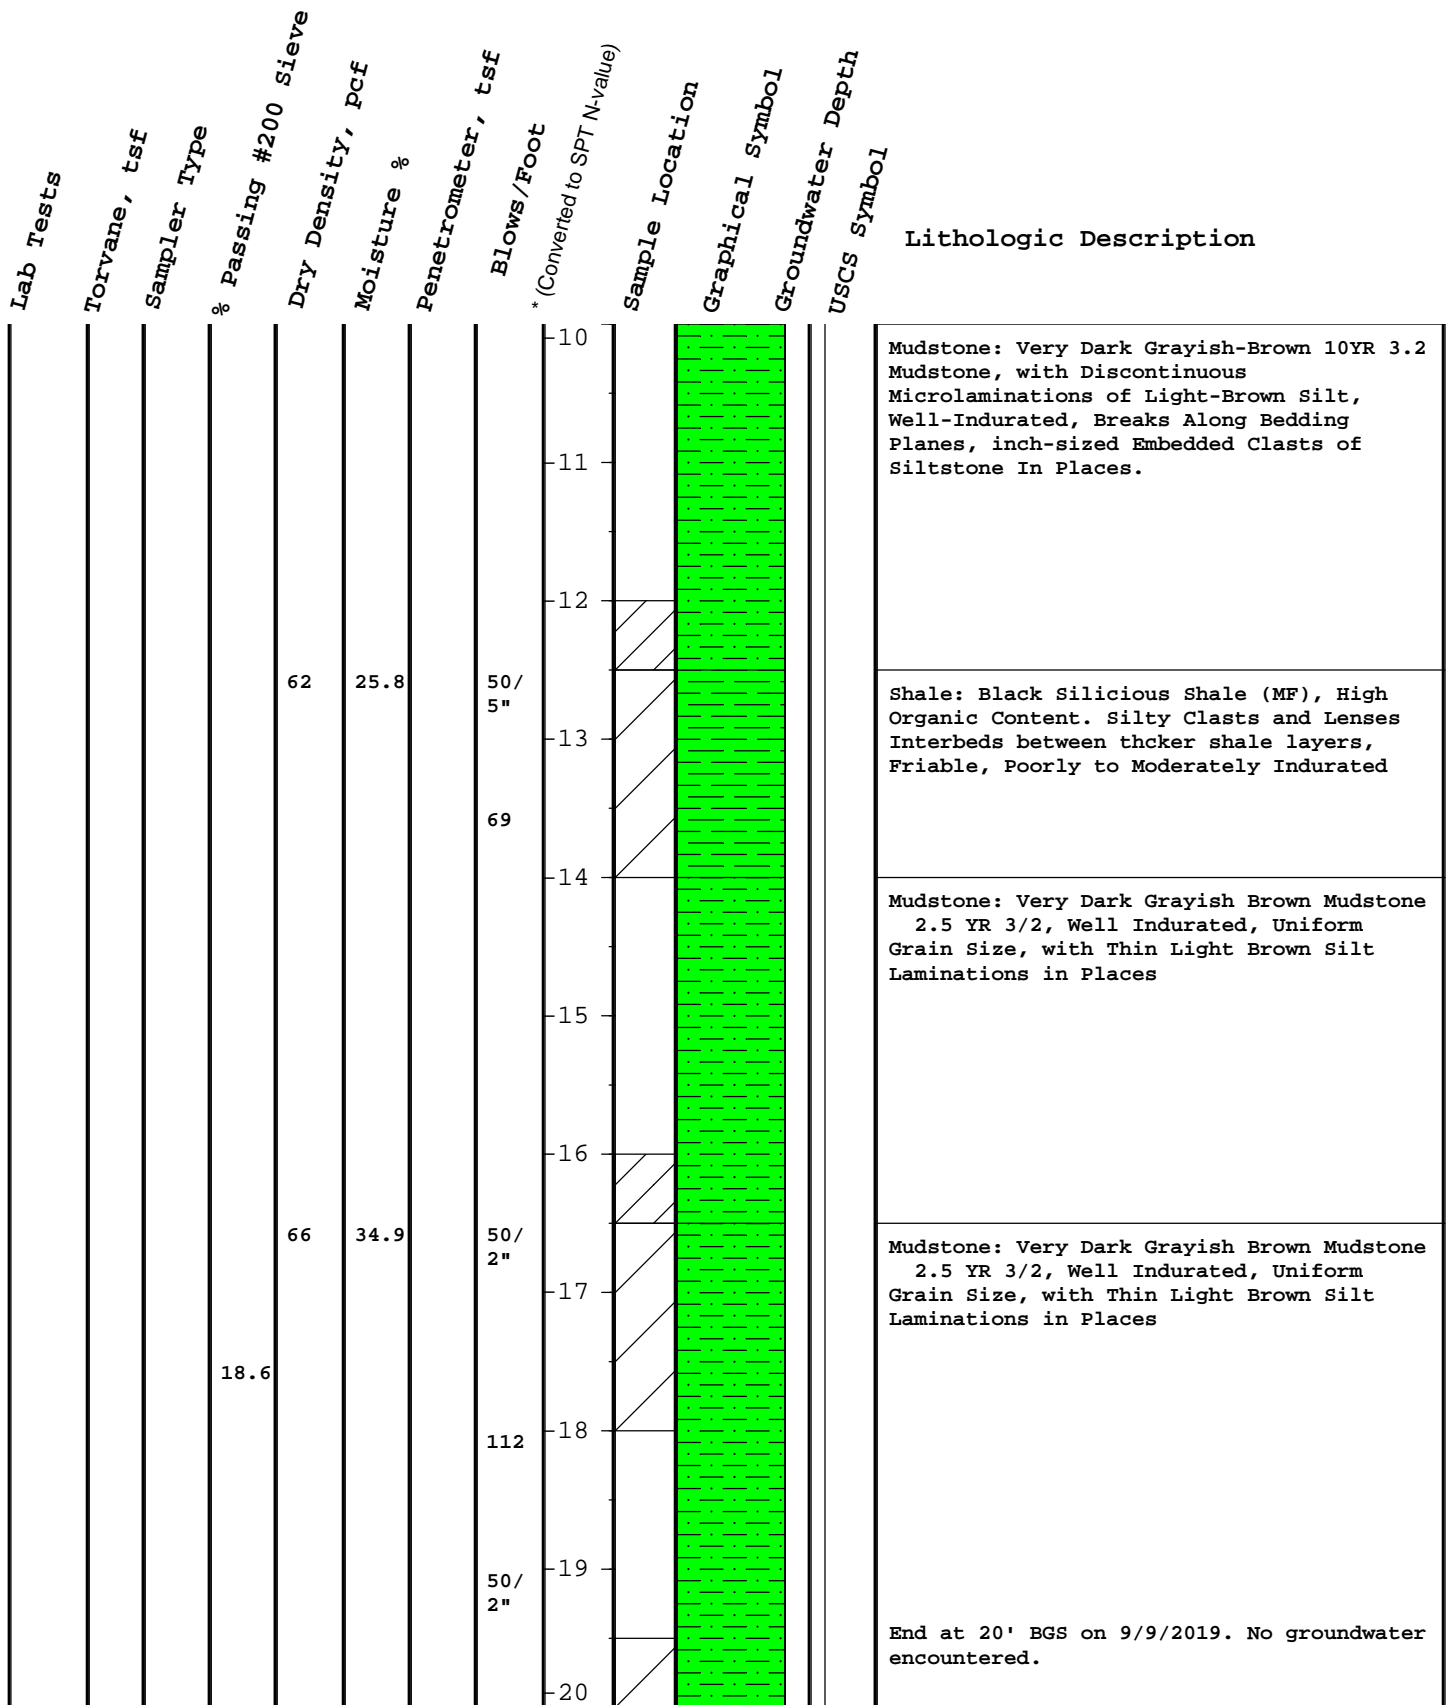
MAJOR DIVISION				TYPICAL NAMES	
COARSE GRAINED SOILS MORE THAN HALF IS LARGER THAN #200 SIEVE	GRAVELS MORE THAN HALF COARSE FRACTION IS LARGER THAN #4 SIEVE SIZE	CLEAN GRAVELS WITH LITTLE OR NO FINES	GW		Well graded Gravels, Gravel-Sand mixtures
			GP		Poorly graded Gravels, Gravel-Sand mixtures
		GRAVELS WITH OVER 12% FINES	GM		Silty Gravels, poorly graded, Gravel-Sand-Silt mixtures
			GC		Clayey Gravels, poorly graded Gravel-Sand-Clay mixtures
	SANDS MORE THAN HALF COARSE FRACTION IS LARGER THAN #4 SIEVE SIZE	CLEAN SANDS WITH LITTLE OR NO FINES	SW		Well graded Sands, Gravelly-Sands
			SP		Poorly graded Sands, Gravelly-Sands
		SANDS WITH OVER 12% FINES	SM		Silty Sands, poorly graded, Sand-Silt mixtures
			SC		Clayey Sands, poorly graded, Sand-Clay mixtures
FINE GRAINED SOILS MORE THAN HALF IS SMALLER THAN #200 SIEVE	SILTS AND CLAYS LIQUID LIMIT LESS THAN 50		ML		Inorganic Silts and very fine Sands, rock flour, Silty or Clayey fine Sands, or Clayey-Silts with slight plasticity

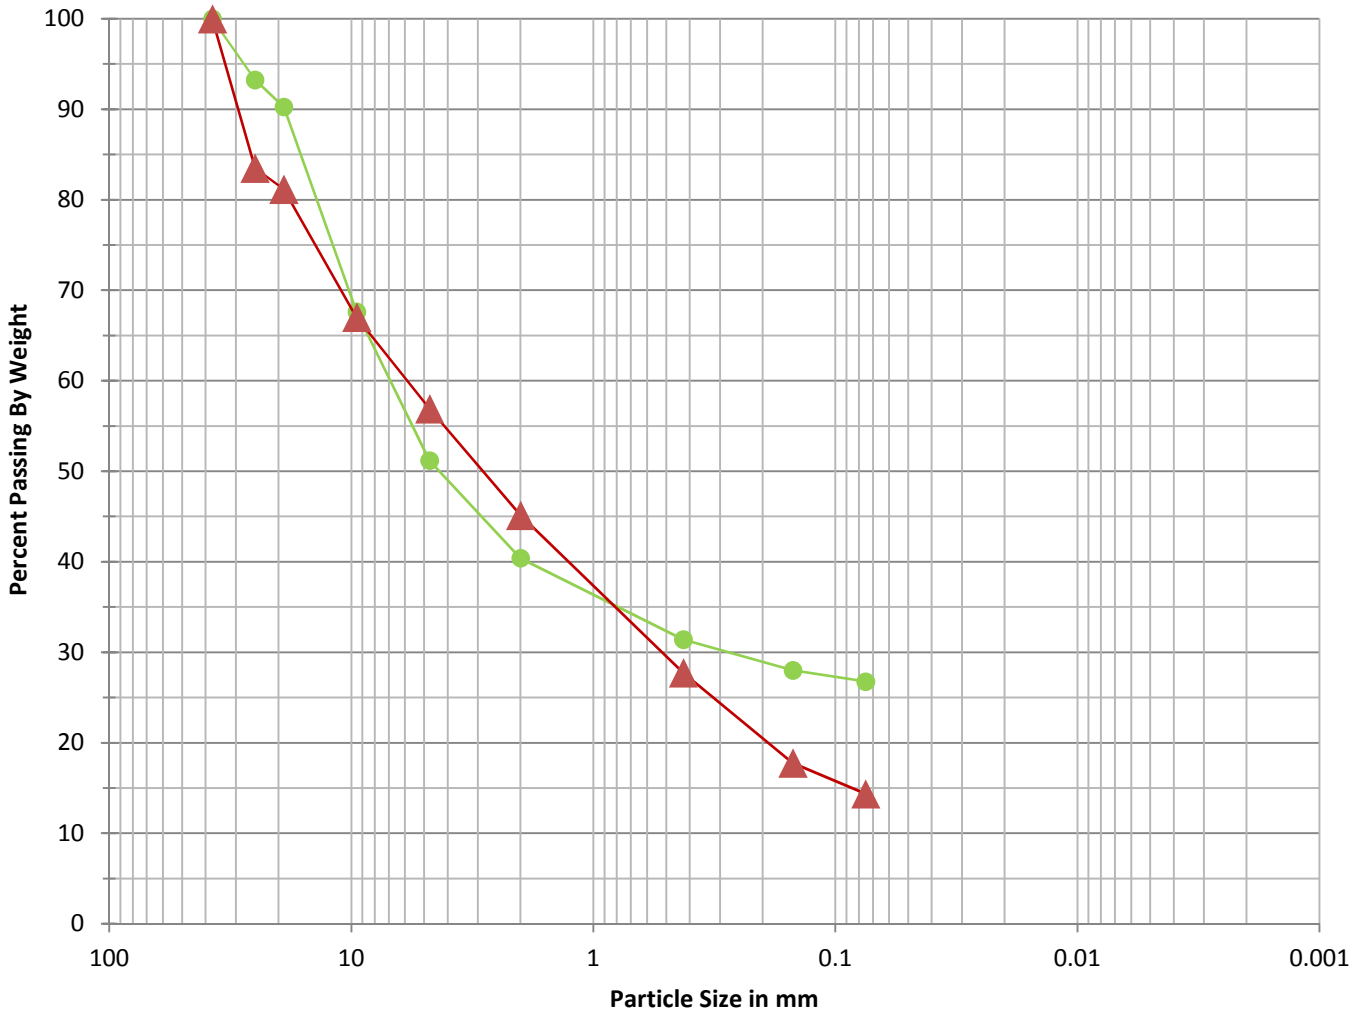
Particle Size Analysis

Gravel		Sand			Silt	Clay
Coarse	Fine	Coarse	Medium	Fine

Symbol	Source
●	B-1, 1.5' - 2'
▲	B-2, 2' - 2.5'

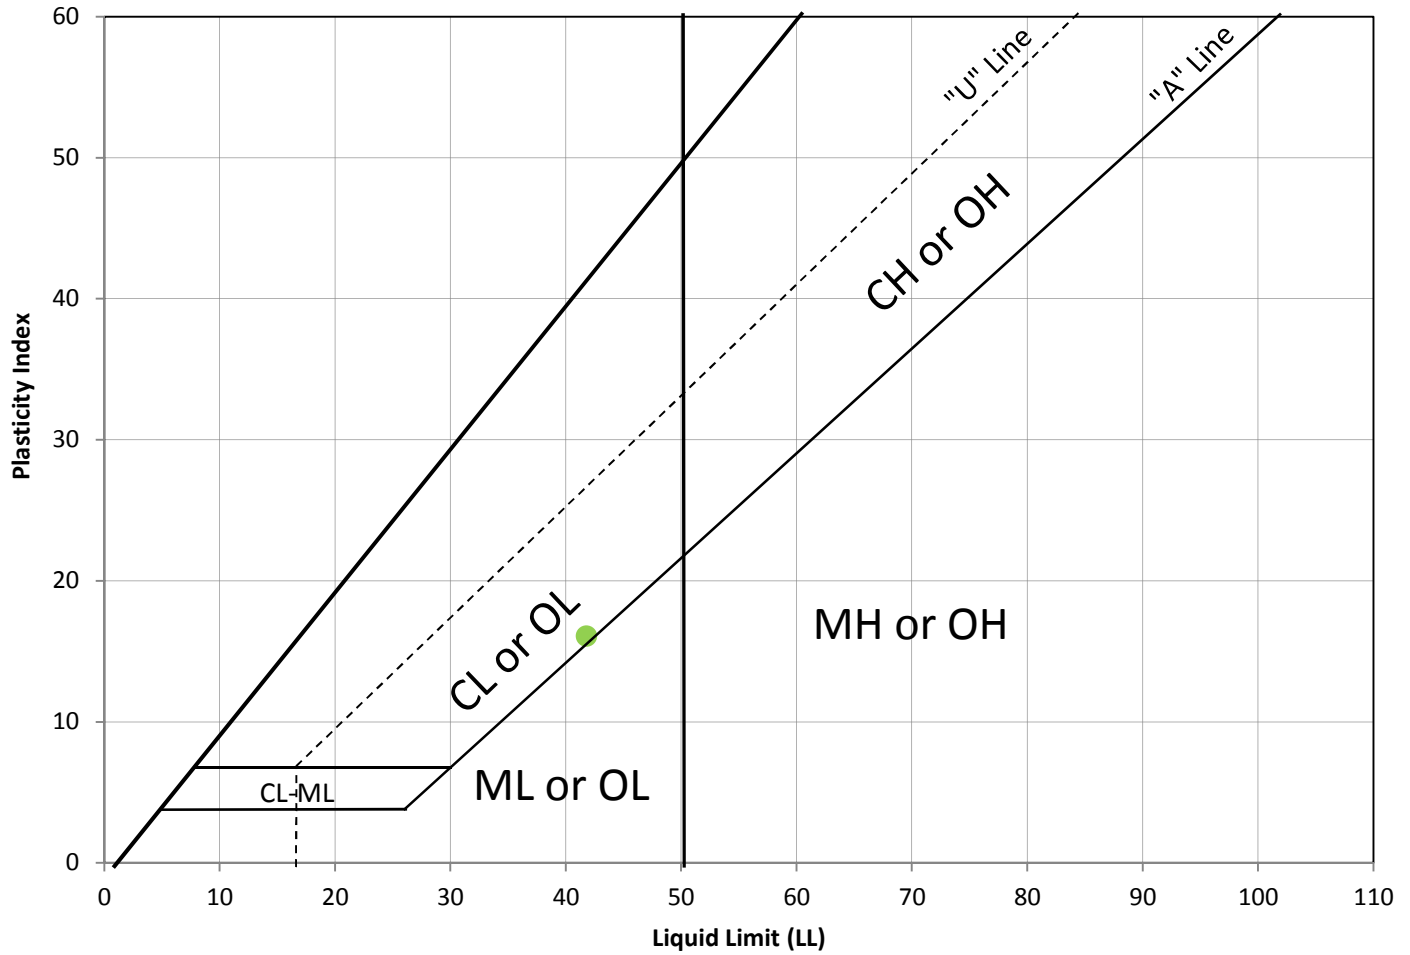
Atterberg Limits

Symbol	Classification & Source	Liquid Limit	Plastic Limit	Plasticity Index	% Passing #200 Sieve
●	Very dark grayish-brown Mudstone, B-2, 7'-7.5'	42	26	16	50.7
