**COUNTY OF SAN MATEO
PLANNING AND BUILDING DEPARTMENT**

SUBJECT: EXECUTIVE SUMMARY: Consideration of an appeal of the Community Development Director's approval of a Grading Permit, pursuant to Section 9283 of the County Grading Regulations, to allow 278 cubic yards of cut and 178 cubic yards of fill in association with the demolition of an existing single-family residence and the construction of a new 3,985 sq. ft. two-story single-family residence with an attached 446 sq. ft. garage and attached 779 sq. ft. accessory dwelling unit located on a legal 7,026 sq. ft. parcel located at 1061 Los Trancos Road in the unincorporated Los Trancos Woods area of San Mateo County. The project involves the removal of seven (7) significant trees in the footprint of the proposed home.

County File Number: PLN 2020-00356 (Awbrey)

The appealed Grading Permit allows 278 cubic yards of cut and 178 cubic yards of fill in association with the demolition of an existing single-family residence and the construction of a new 3,985.7 sq. ft. two-story single-family residence with an attached 446 sq. ft. garage and attached 779.9 sq. ft. accessory dwelling unit located on a legal 7,026 sq. ft. parcel. The

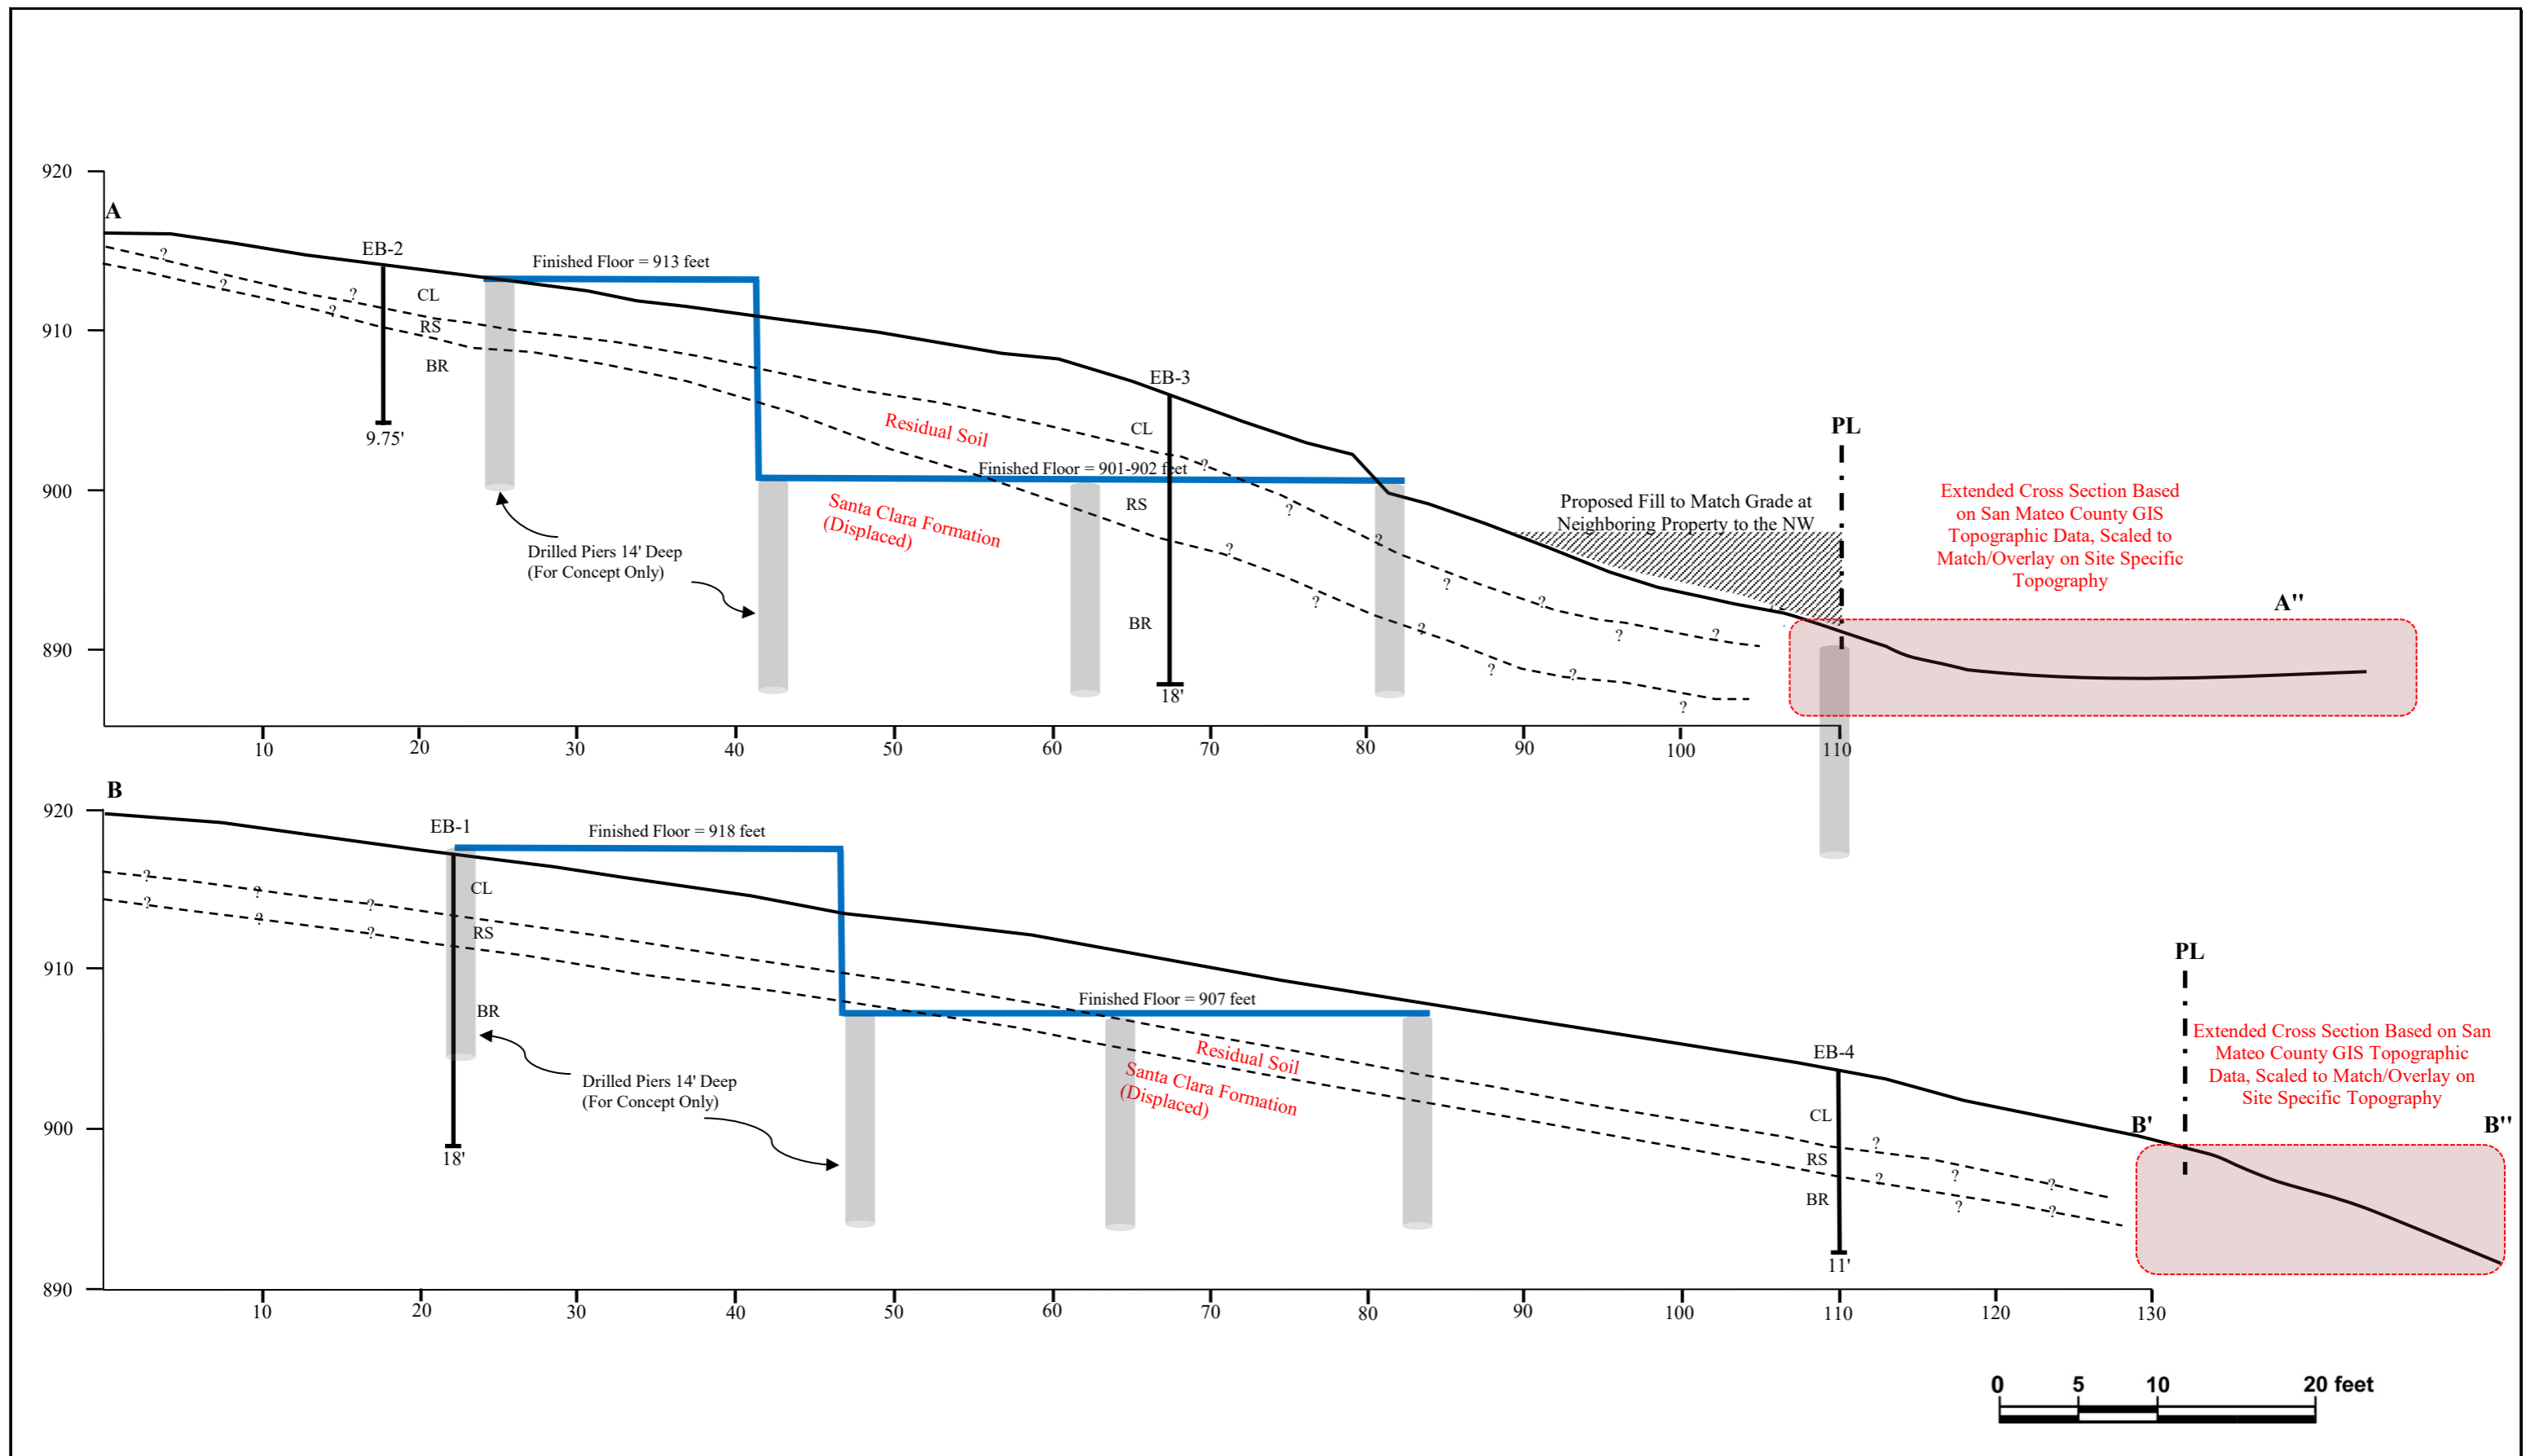
EXTENDED GEOLOGIC CROSS SECTIONS A-A' AND B-B'
 AWBREY RESIDENCES (RESPONSE TO CSA COMMENTS)
 PORTOLA VALLEY, CALIFORNIA

In addition, we expanded our local site cross sections to include the areas immediately downslope of the site(s) by utilizing San Mateo County GIS topography provided to us. Based on the extensions to our cross sections, shown on Supplemental Figures 3 and 4, grades appear to flatten downslope of the northern lot and appear to slope down relatively uniformly with a moderate grade beyond the south lot. We have also depicted the basement and at-grade areas to be supported on drilled pier foundations and have shown the proposed fill and lower retaining wall in the north corner of the northern lot.
