MEMORANDUM

DATE: January 19, 2024
TO: Mark Chow, County of San Mateo
FROM: Ben Shick, PE
SUBJECT: Crystal Springs County Sanitation District – Pipe
and Manhole Assessment and Recommendations

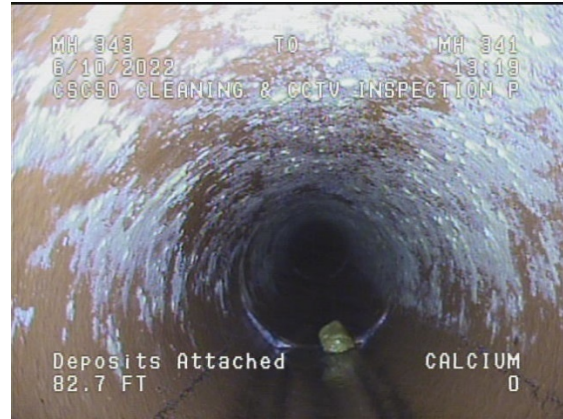
Example 2: Calcium Deposits

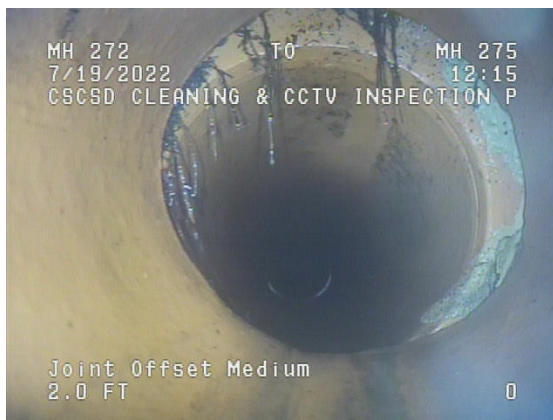
Example 5: Medium Offset Joint

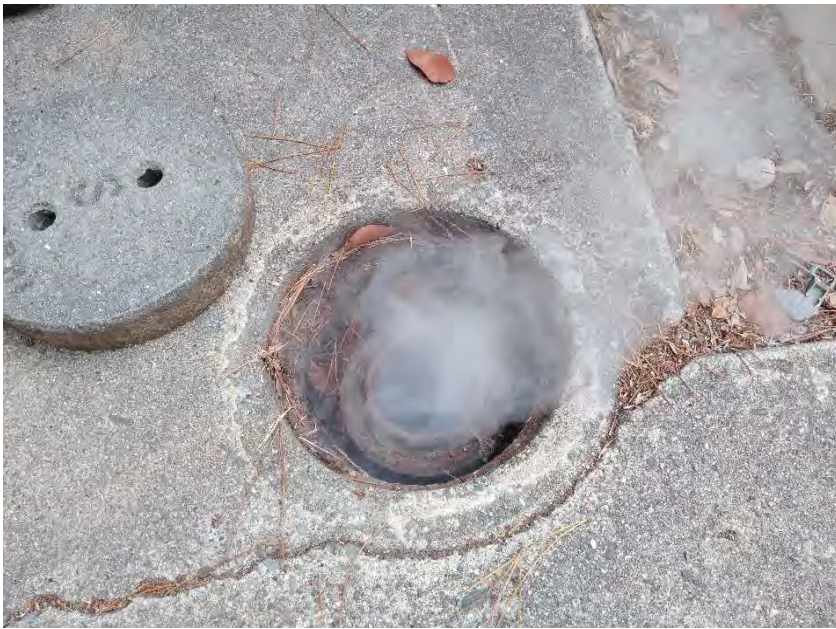
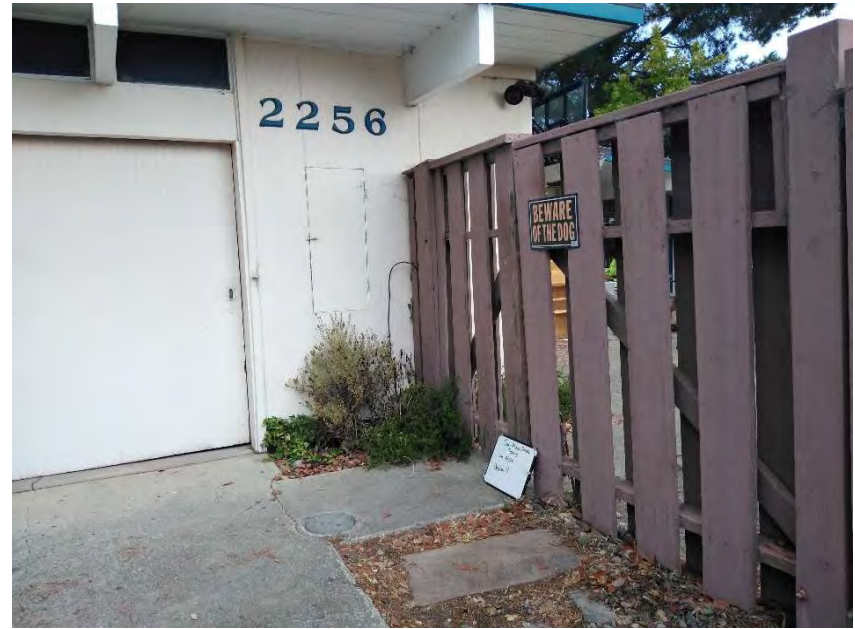
Project: San Mateo Smoke Testing 2019
Date: 8/7/2019
Defect: 008

Defect #	Address/Location	Results	Status	Source Type	Smoke	Area		Run Off	Photo #
						FT	FT		
008	2256 Bunker Hill Dr	1	1	16	2	4"	4"	5

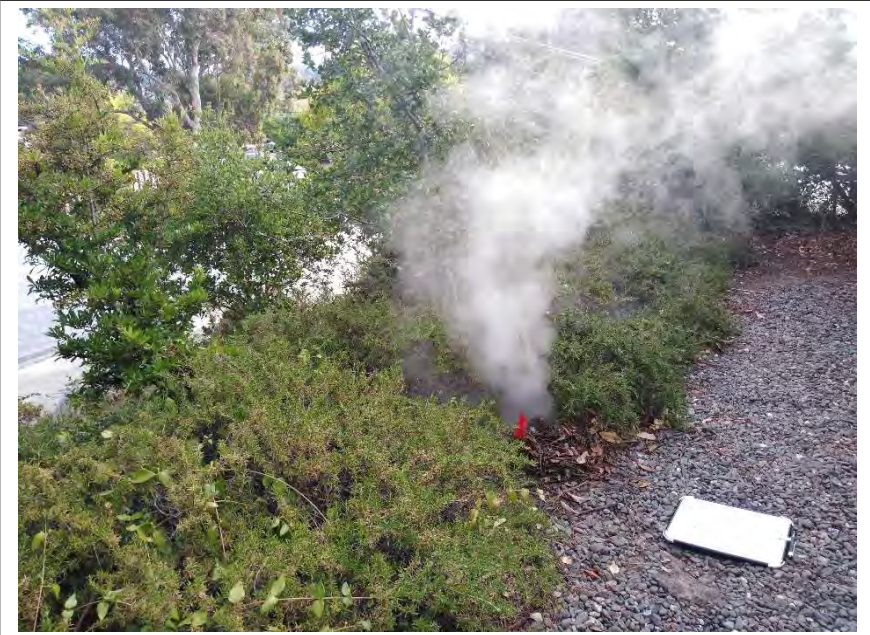
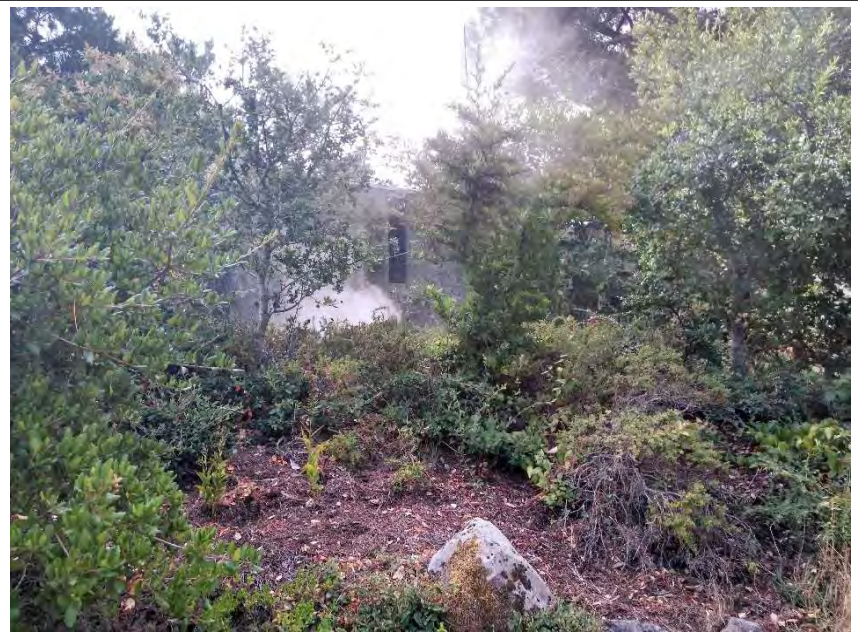
Project: San Mateo Smoke Testing 2019
Date: 8/7/2019
Defect: 009

Defect #	Address/Location	Results	Status	Source Type	Smoke	Area		Run Off	Photo #
						FT	FT		
009	2253 Bunker Hill Dr	1	1	1	3	12'	8'	2

Comments: Could be burried cleanout but could not locate

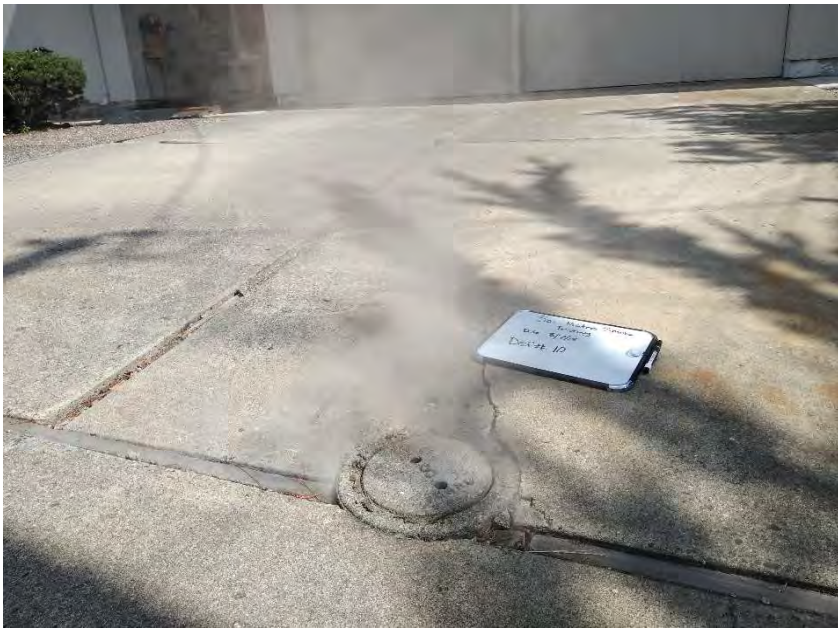
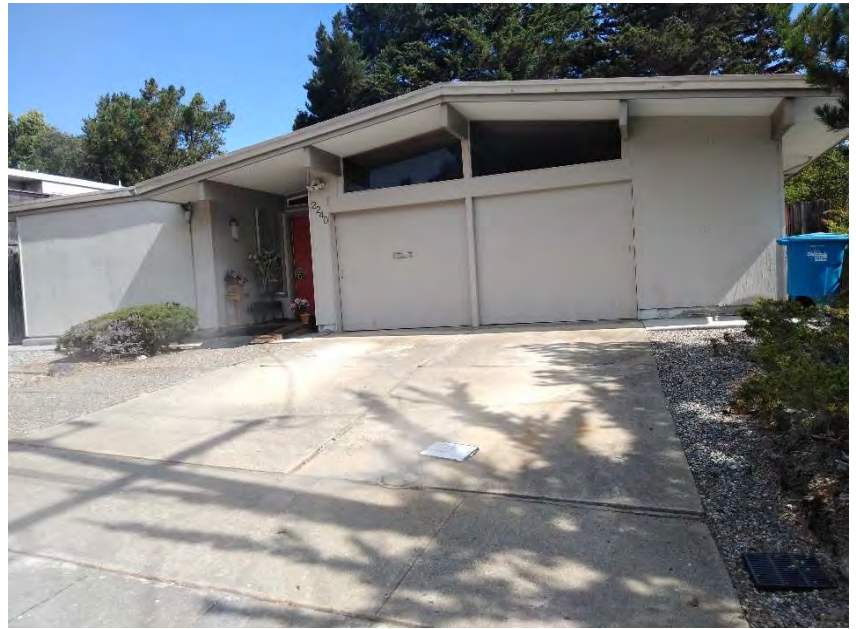
Project: San Mateo Smoke Testing 2019
Date: 8/7/2019
Defect: 010

Defect #	Address/Location	Results	Status	Source Type	Smoke	Area		Run Off	Photo #
						FT	FT		
010	2240 Bunker Hill Dr	1	1	16	3	10'	6'	5

Comments: No cap

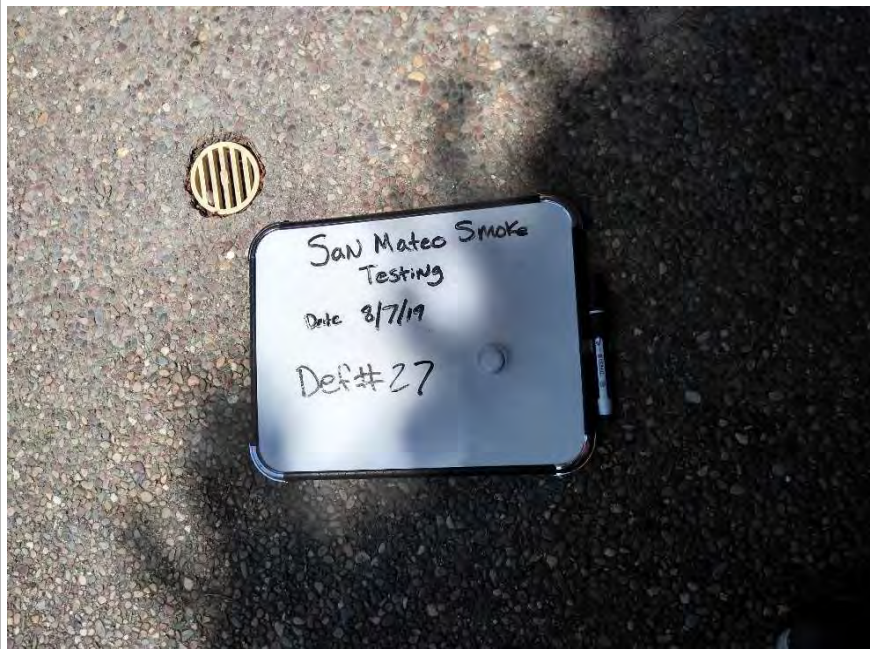
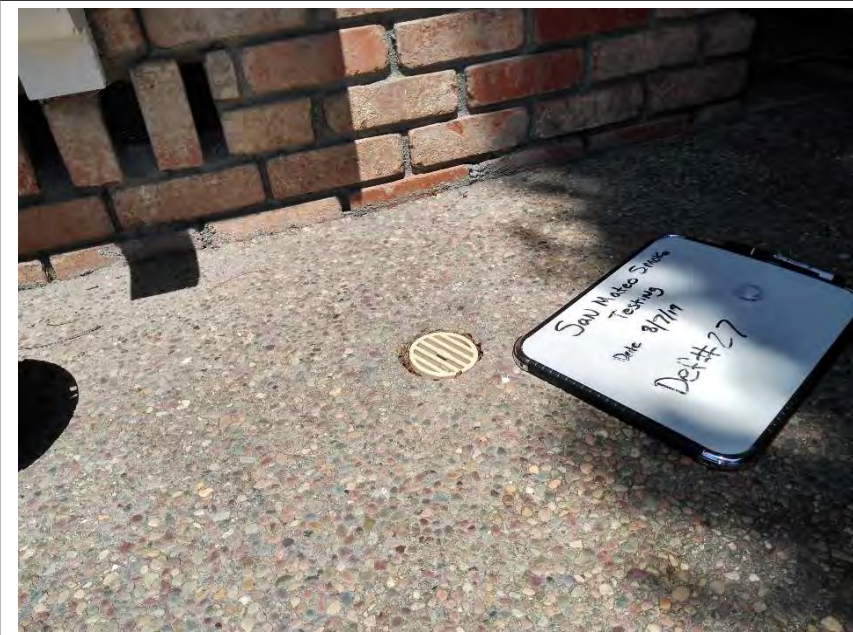
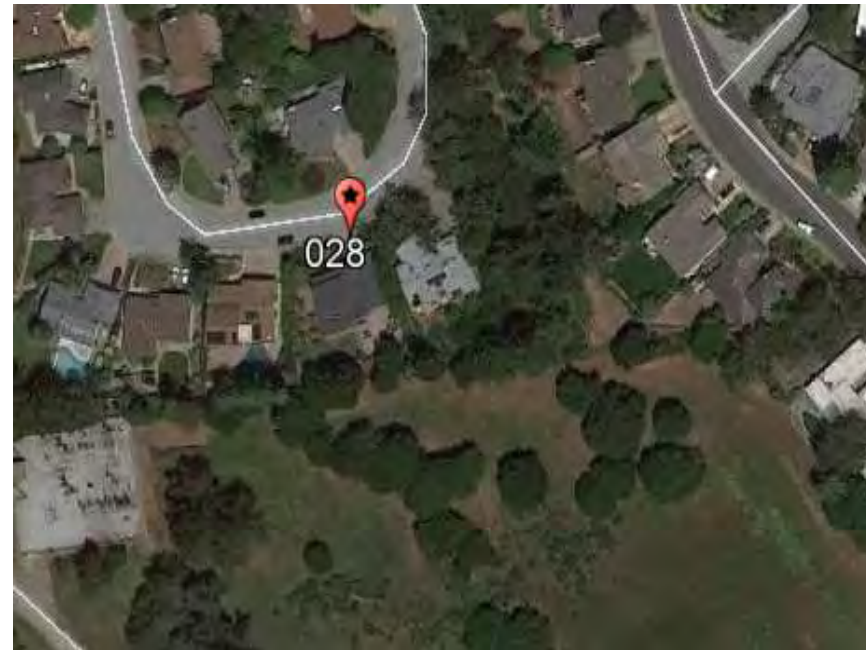
Project: San Mateo Smoke Testing 2019
Date: 8/7/2019
Defect: 027

Comments: Area drain not lowest point

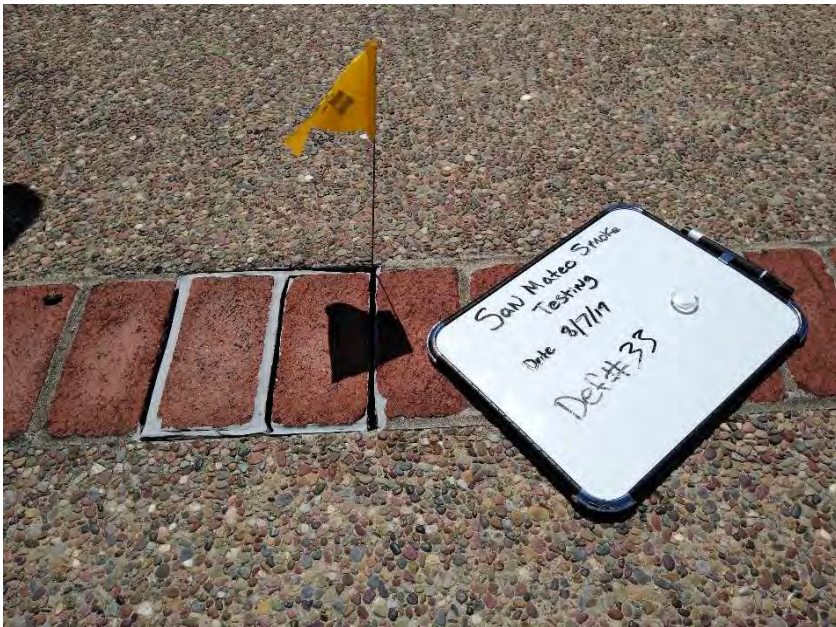
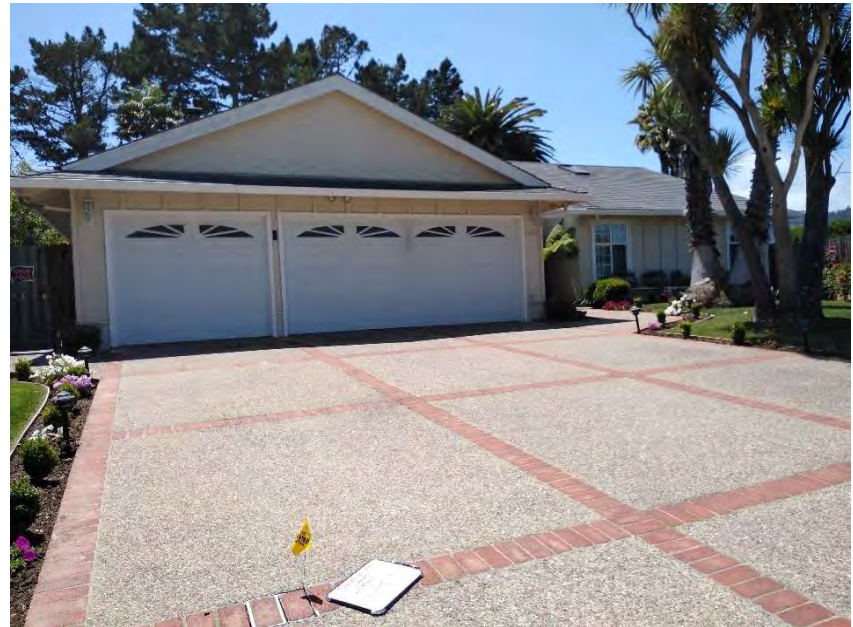
Project: San Mateo Smoke Testing 2019
Date: 8/7/2019
Defect: 033

Comments: Rusty/Deteriorated Cap

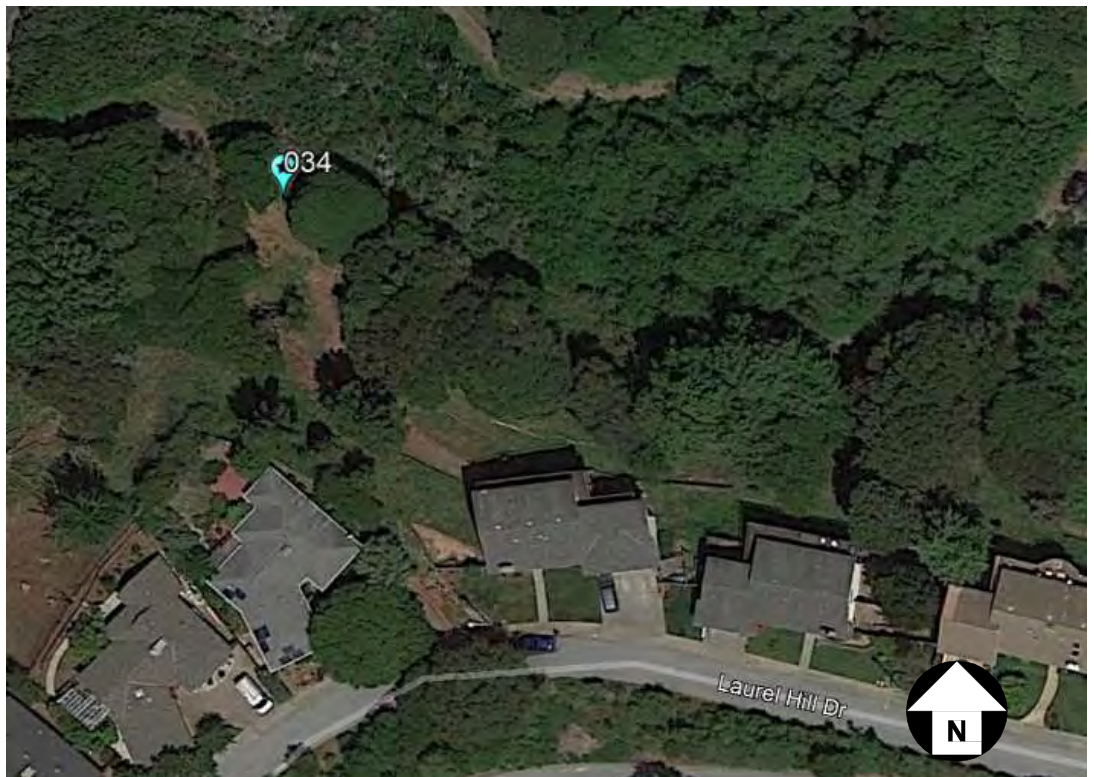
Project: San Mateo Smoke Testing 2019
Date: 8/7/2019
Defect: 034

Comments: Smoke coming from next to manhole lid

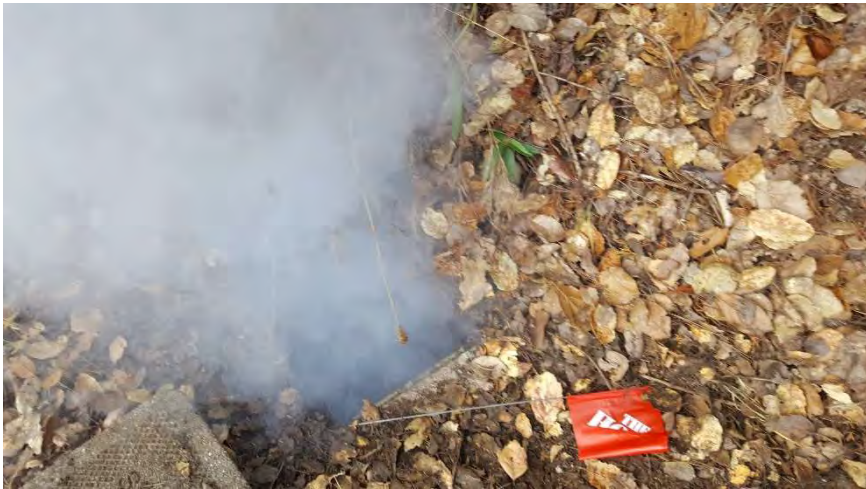
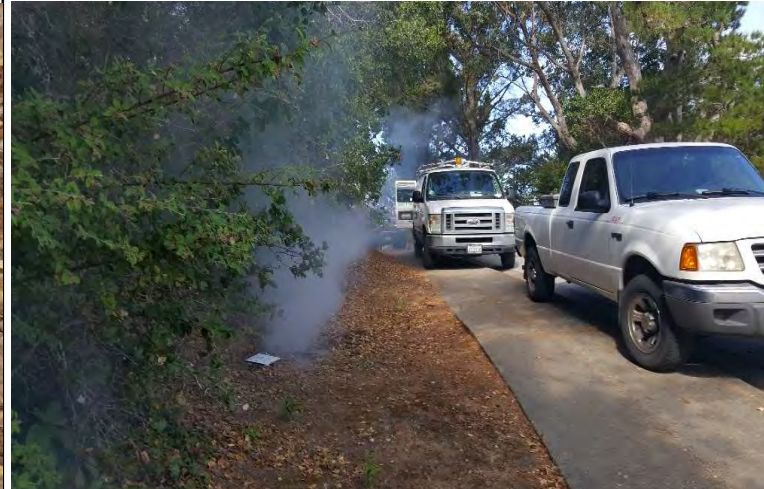
Project: San Mateo Smoke Testi
Date: 8/8/2019
Defect: 036

Comments: Missing cap; low spot; Backside of property

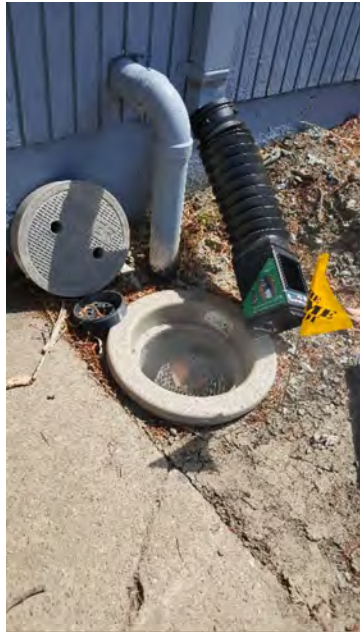
Project: San Mateo Smoke Testing 2019
Date: 8/8/2019
Defect: 043

Comments: Downspout draining into cleanout.

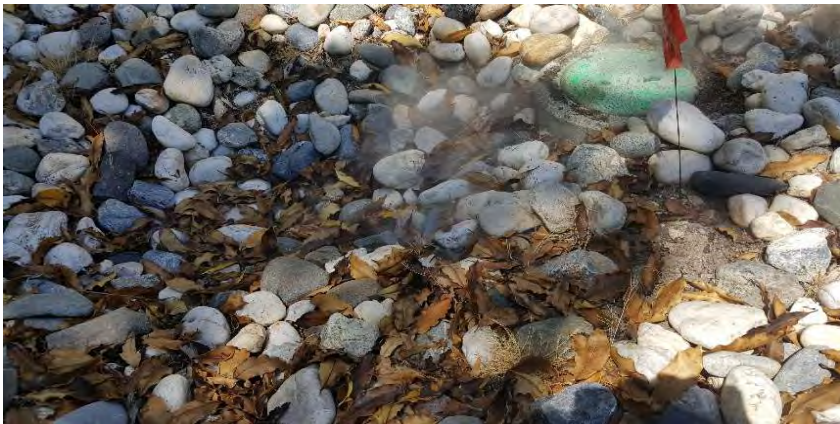
Project: San Mateo Smoke Testing 2019
Date: 8/8/2019
Defect: 045

045: May have cracked lateral or the cleanout is just off the

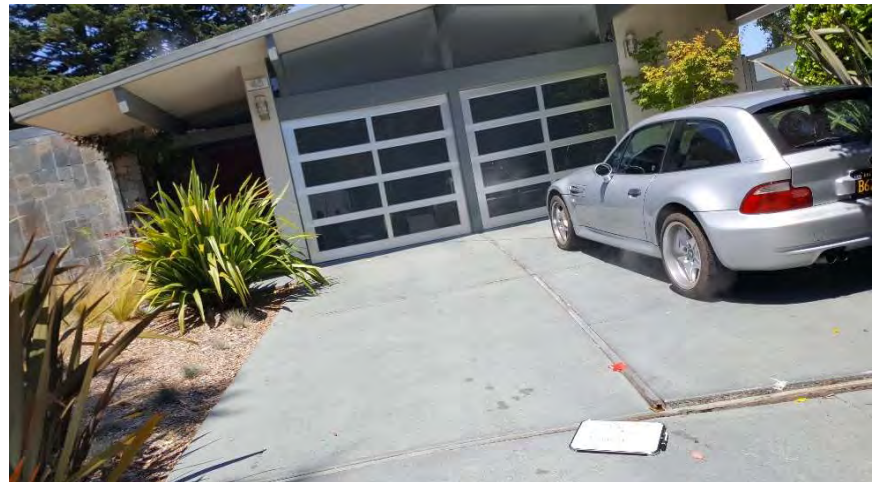
Project: San Mateo Smoke Testing 2019
Date: 8/8/2019
Defect: 059

Comments: 059: Smoke coming from concrete joints in driveway. Water should drain into crack
 060: Smoke coming from edge of concrete and dirt. Water should drain into this edge

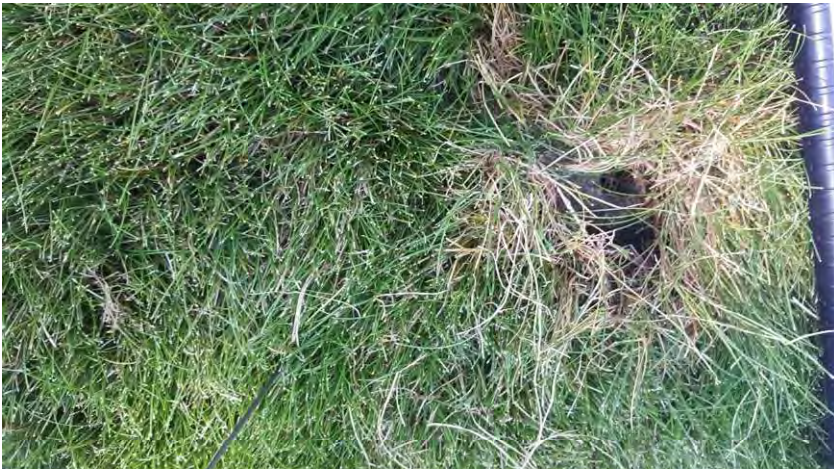
Project: San Mateo Smoke Testing 2019
Date: 8/8/2019
Defect: 063

Comments: 063: Could not open. A low area. 064: No cap

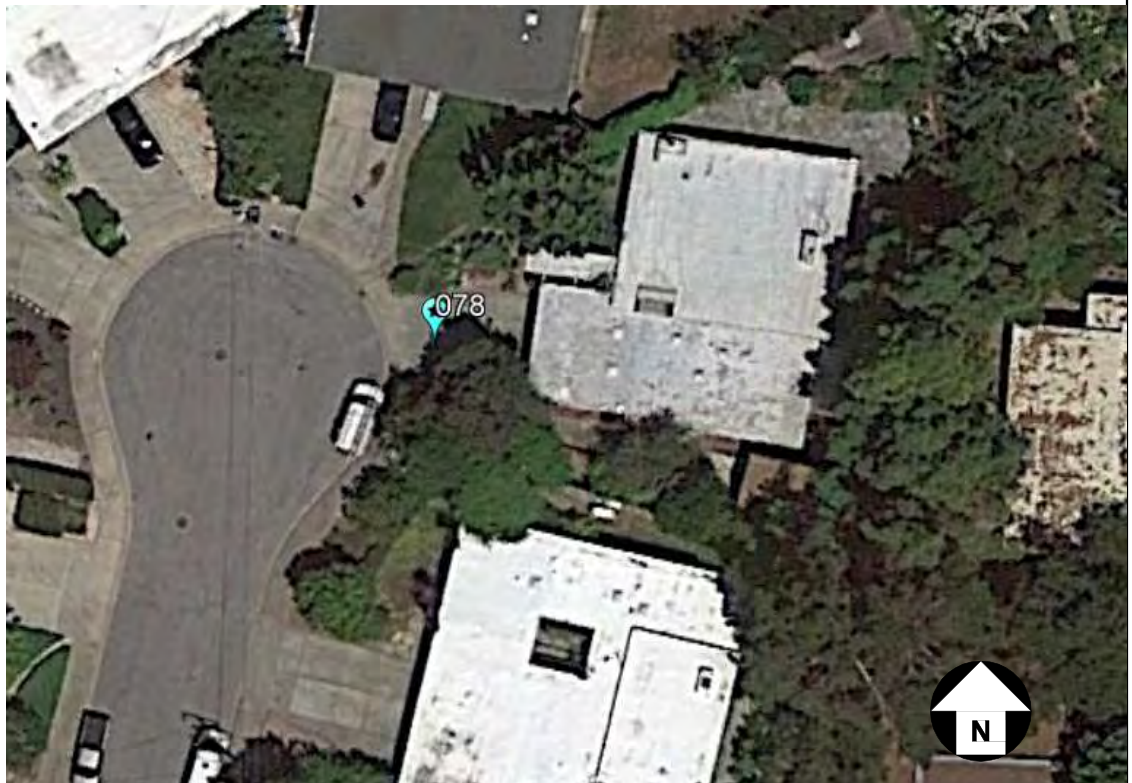
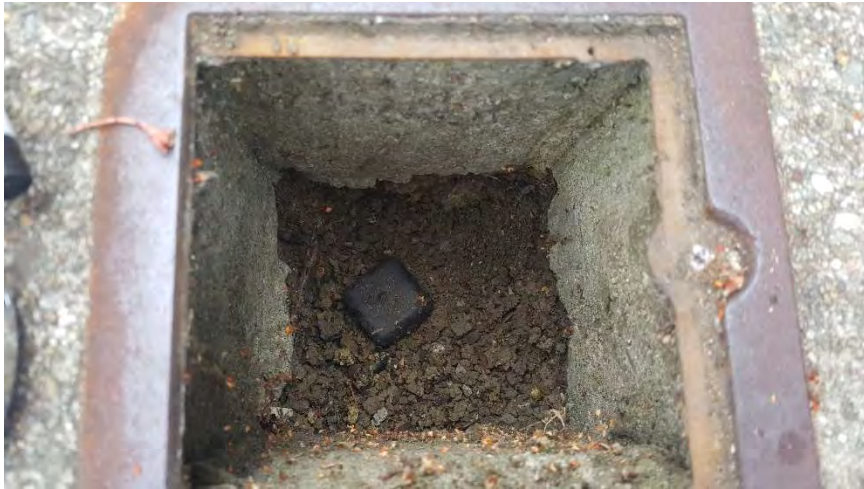
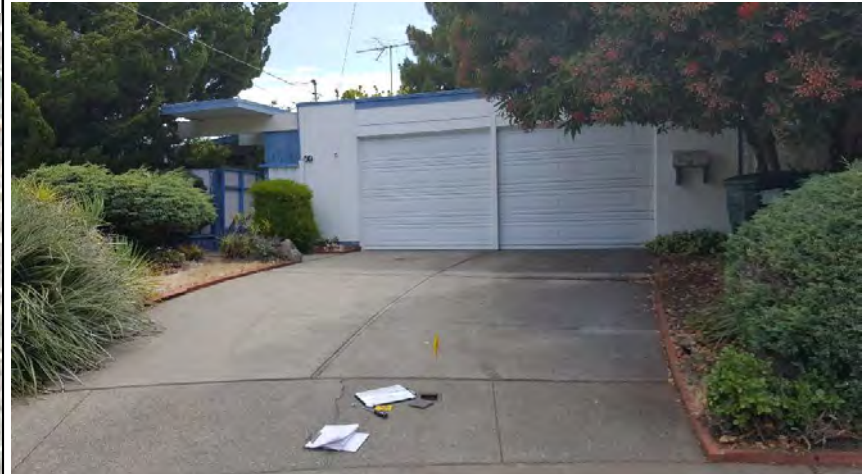
Project: San Mateo Smoke Testing 2019
Date: 8/9/2019
Defect: 078

Defect #	Address/Location	Results	Status	Source Type	Smoke	Area		Run Off	Photo #
						FT	FT		
078	50 Trenton Pl	1	1	16	1	6'	10'	5

Comments: Water flows over and will drain into cleanout

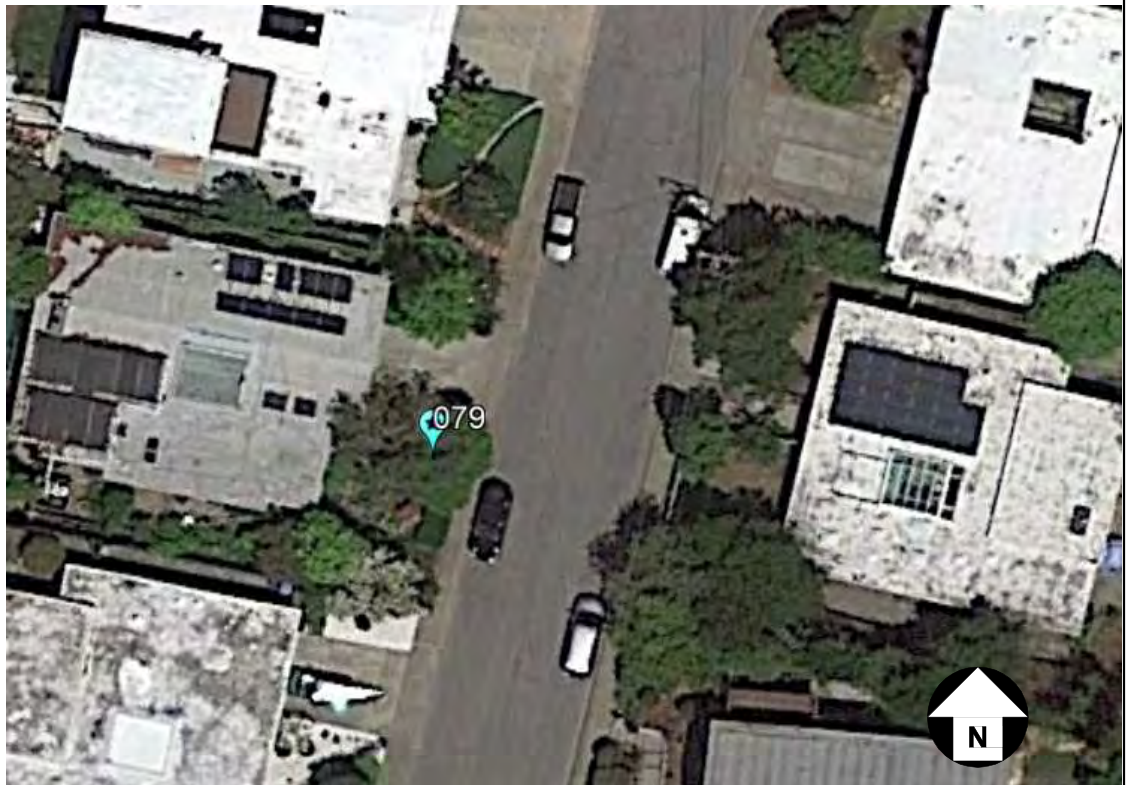
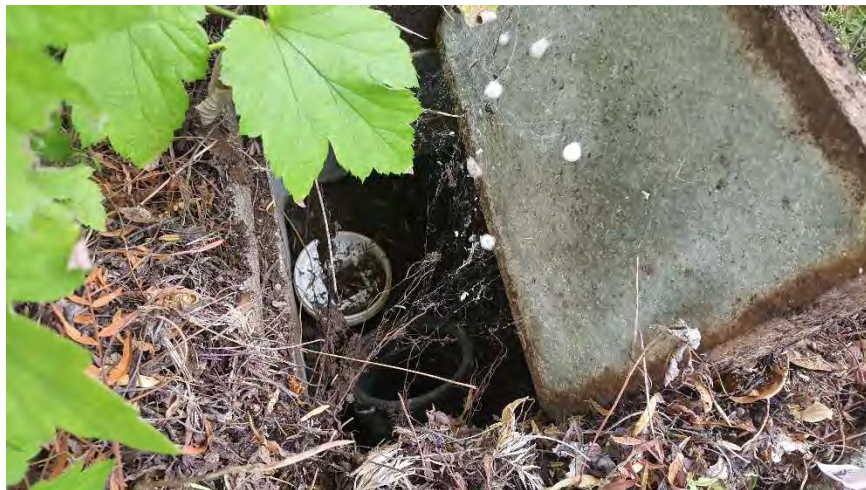
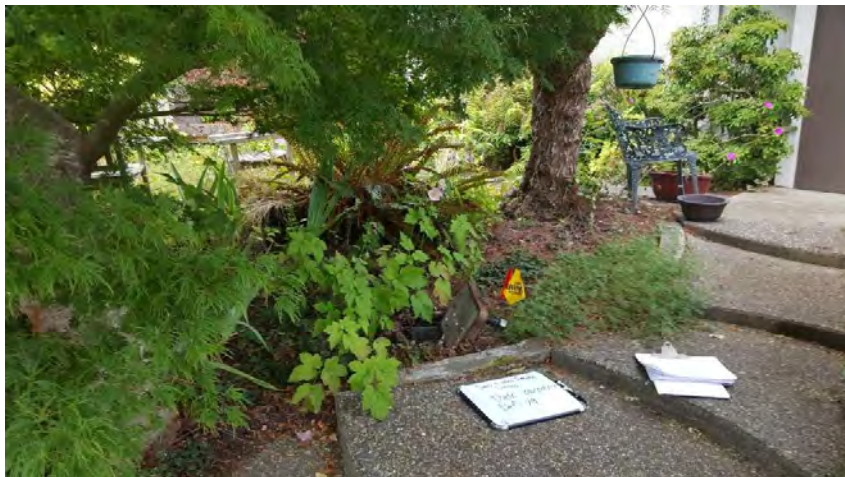
Project: San Mateo Smoke Testing 2019
Date: 8/9/2019
Defect: 079

Defect #	Address/Location	Results	Status	Source Type	Smoke	Area		Run Off	Photo #
						FT	FT		
079	35 Trenton Pl	1	1	16	1	4'	4'	2

Comments: Cap off. Low point could drain into cleanout

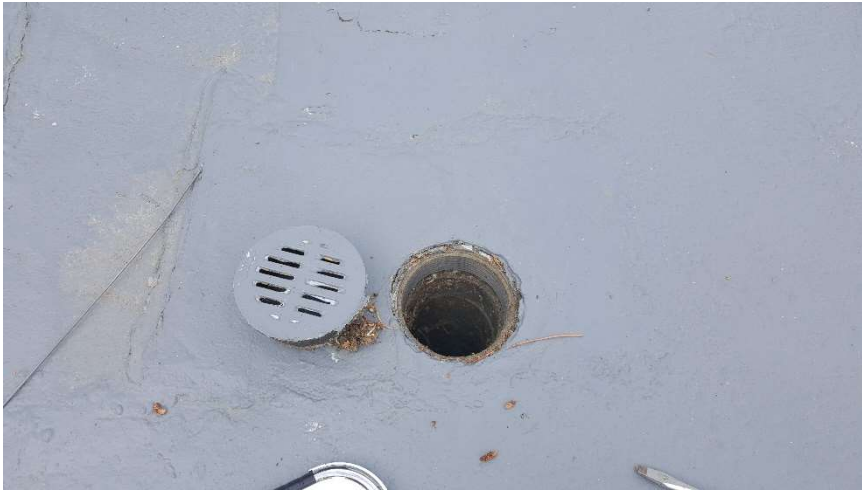
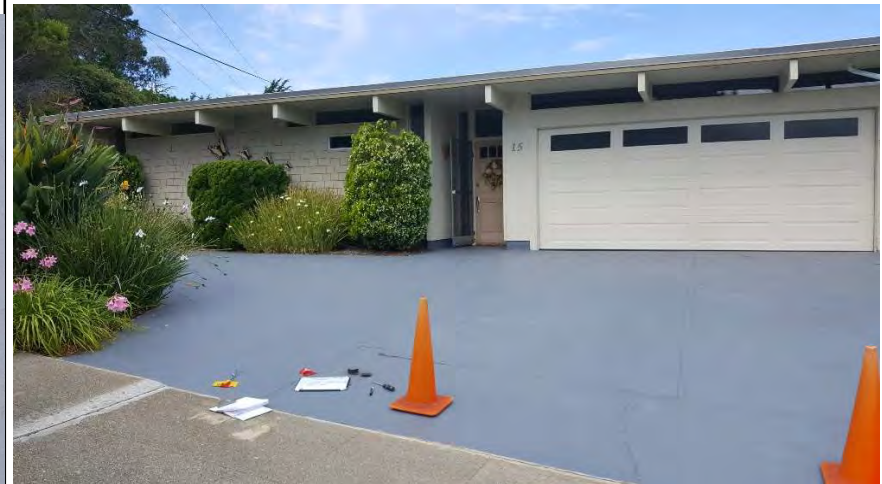
Project: San Mateo Smoke Testing 2019
Date: 8/9/2019
Defect: 080

Defect #	Address/Location	Results	Status	Source Type	Smoke	Area		Run Off	Photo #
						FT	FT		
080	15 Trenton Pl	1	1	6	1	6'	12'	5

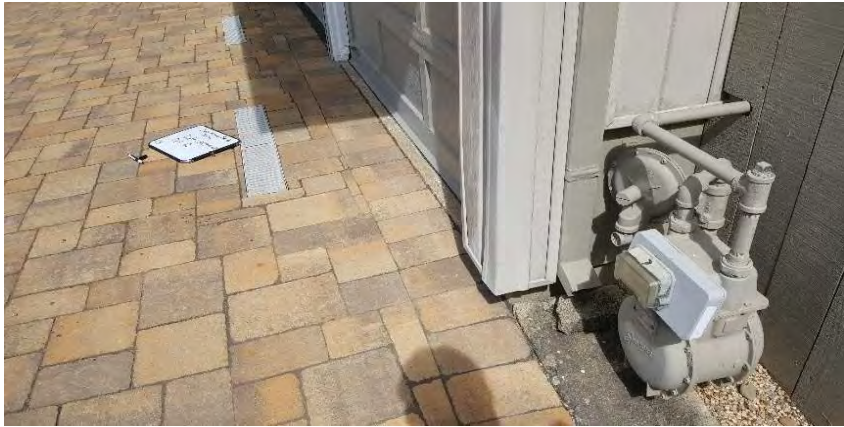
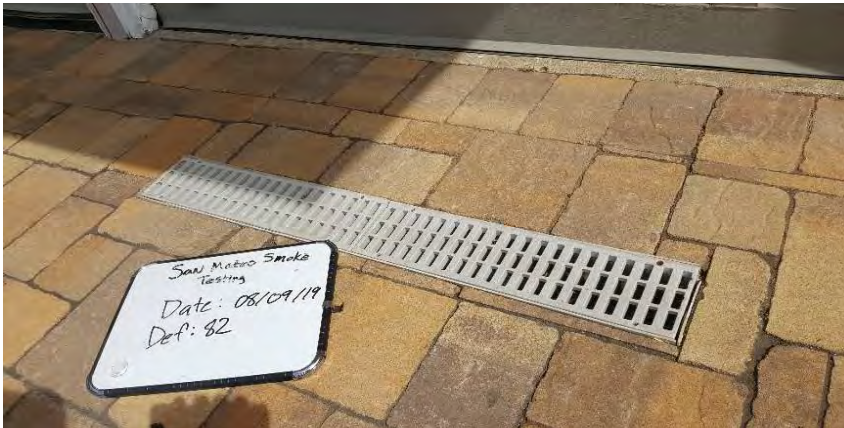
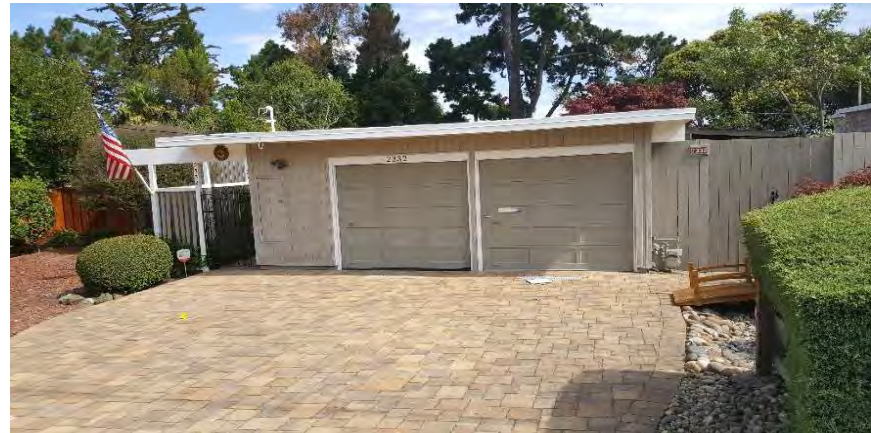
Project: San Mateo Smoke Testing 2019
Date: 8/9/2019
Defect: 082

Comments: 081: Area drain low point of driveway. 082: Gutters feed to these drains.

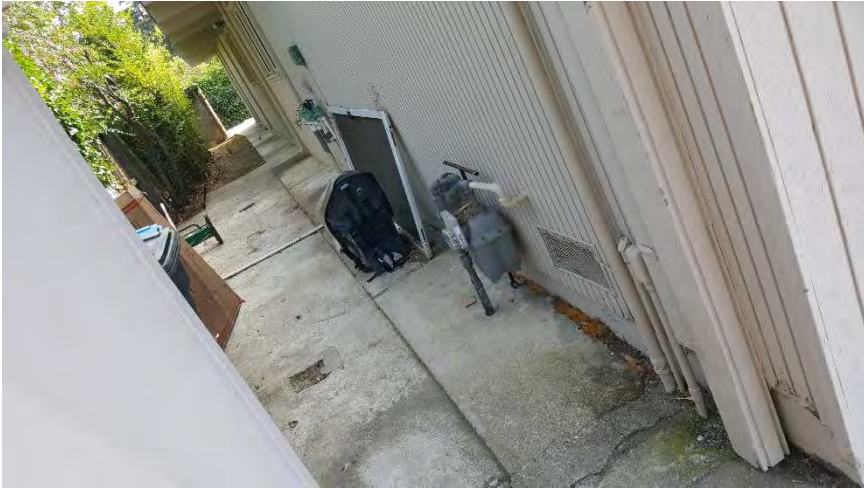
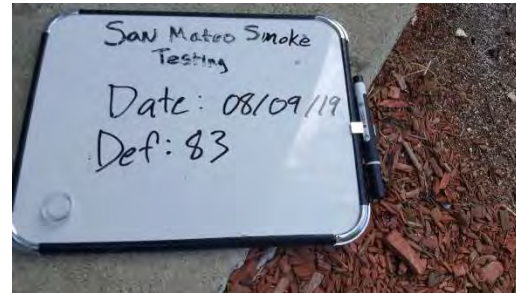
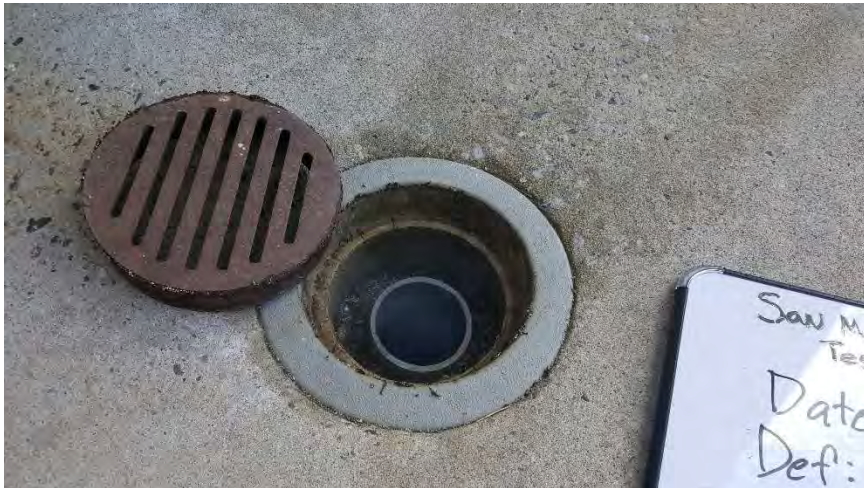
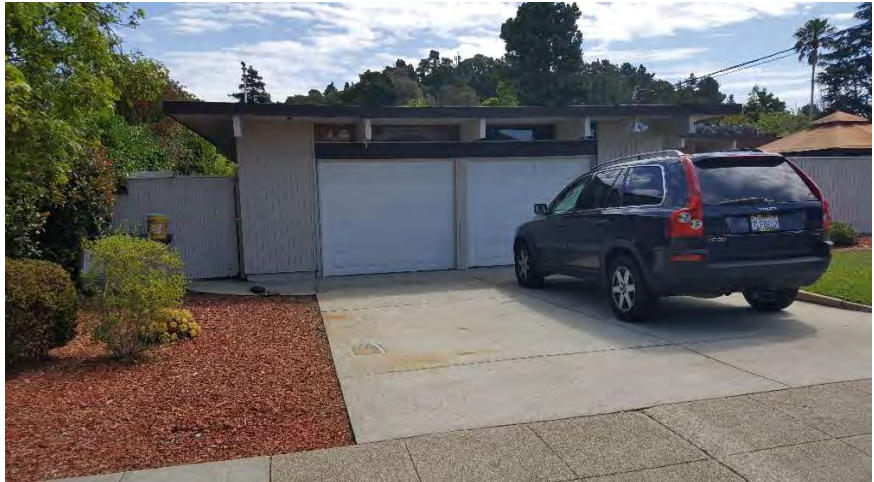
Project: San Mateo Smoke Testing 2019
Date: 8/9/2019
Defect: 083

Comments: Main area drain of entire driveway and gutters also drain here

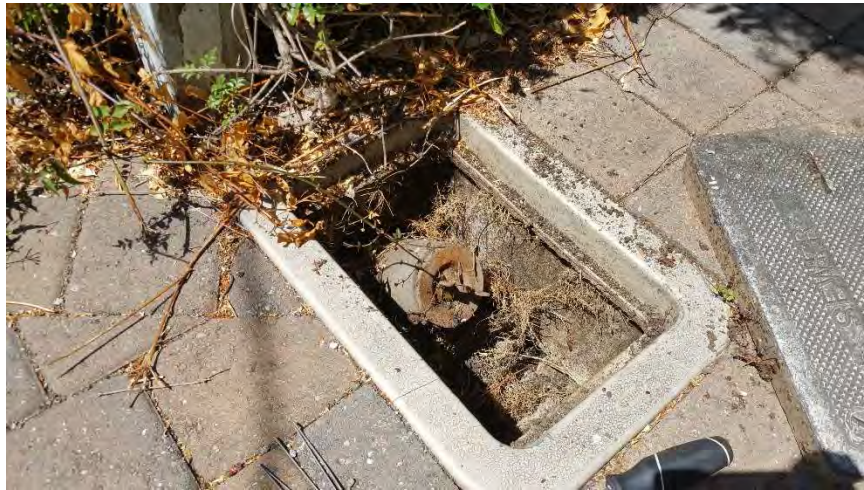
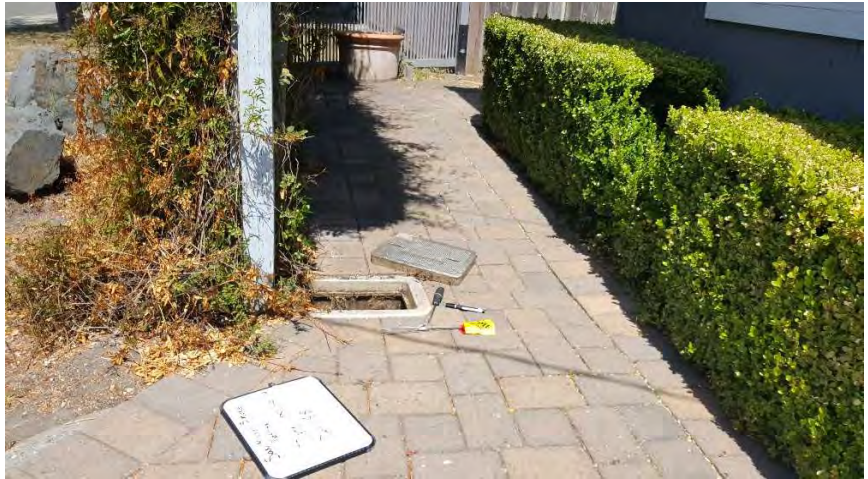
Project: San Mateo Smoke Testing 2019
Date: 8/9/2019
Defect: 088

Comments: low spot; cap loose

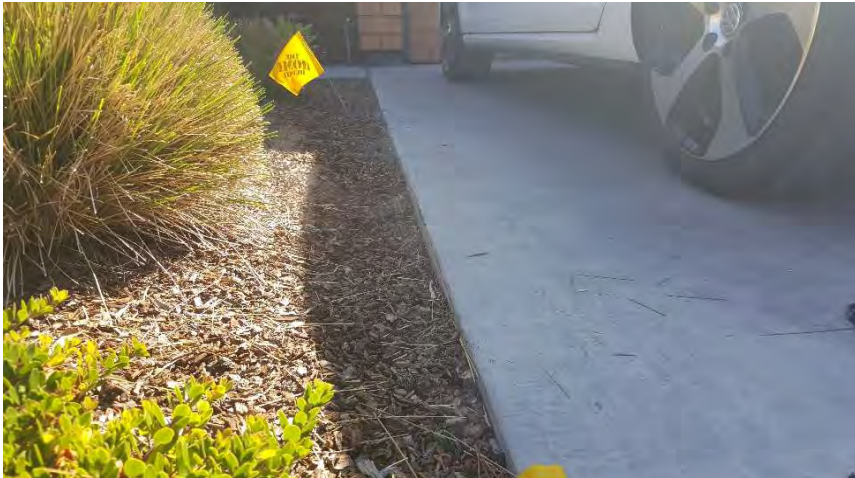
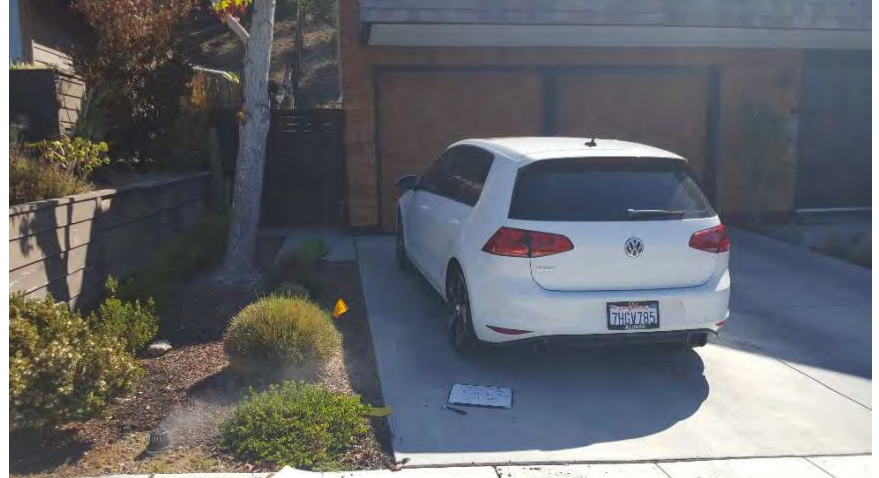
Project: San Mateo Smoke Testing 2019
Date: 8/13/2019
Defect: 100

Comments: 100: Smoke coming from edge of pavement.

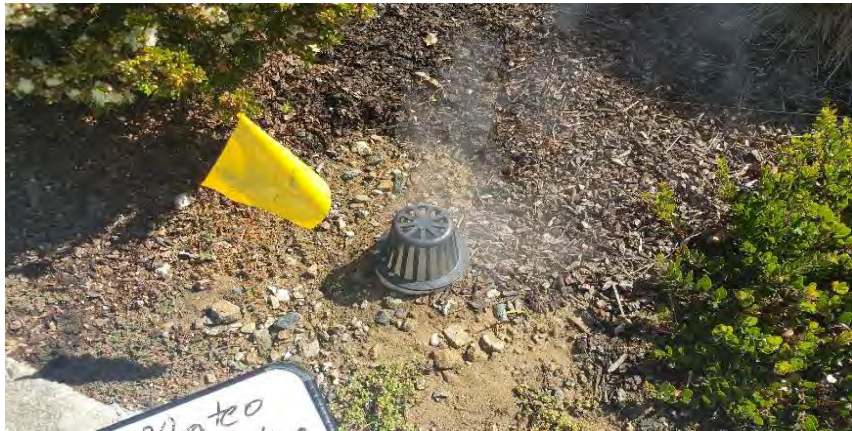
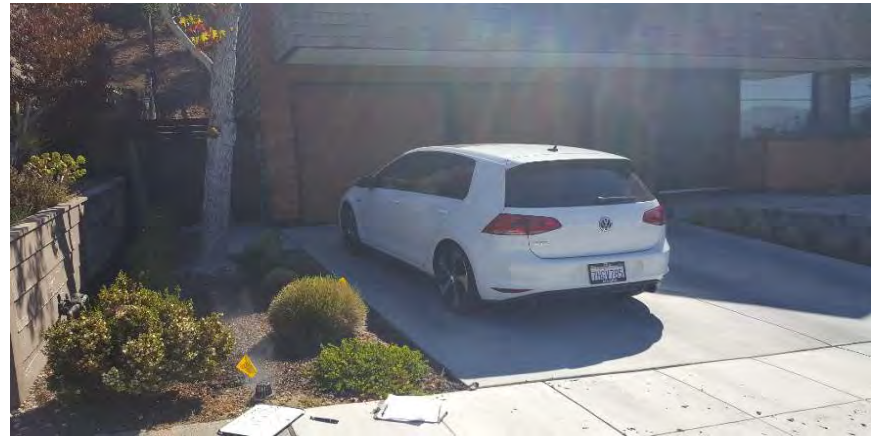
Project: San Mateo Smoke Testing 2019
Date: 8/13/2019
Defect: 101

101: Area drain maybe cleanout

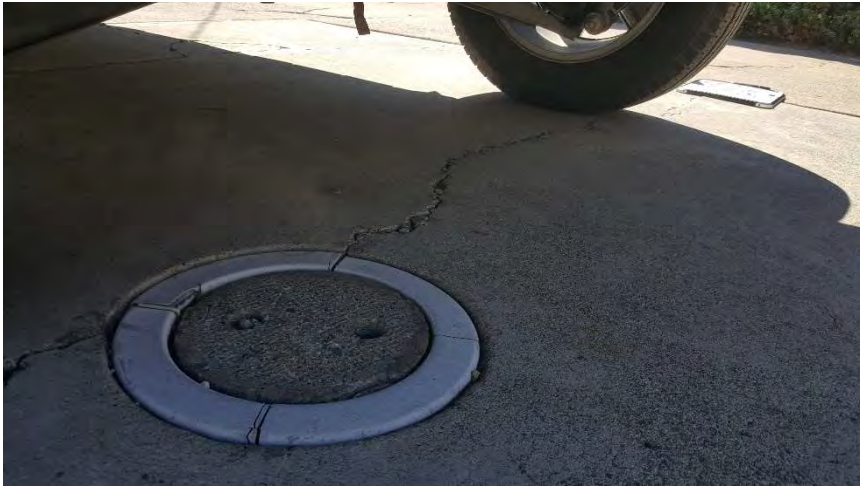
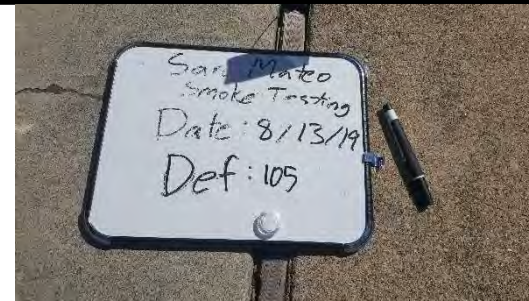
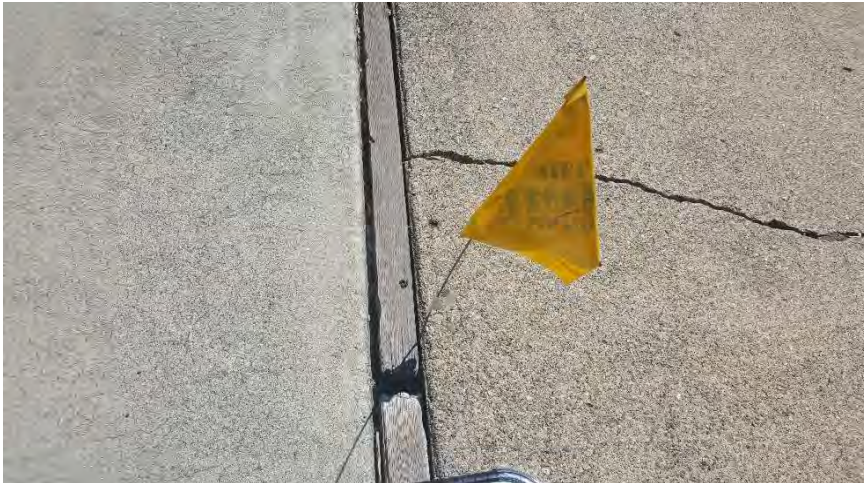
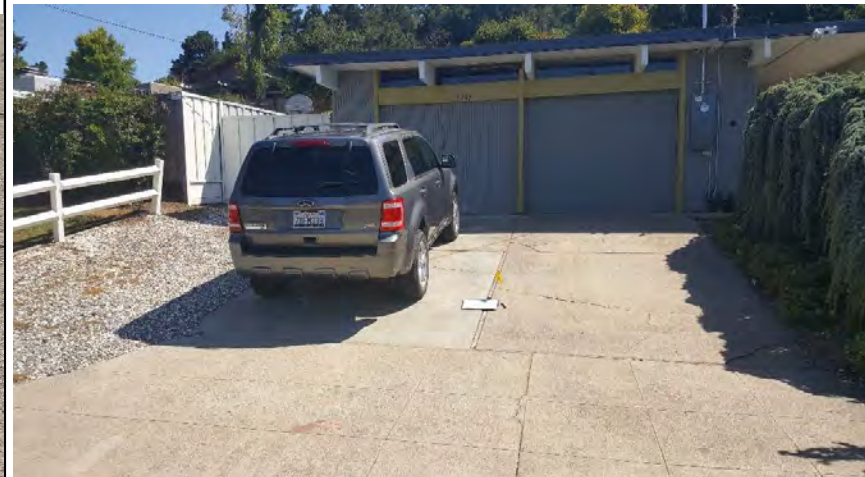
Project: San Mateo Smoke Testing 2019
Date: 8/13/2019
Defect: 105

Comments: Smoke coming from cracks in driveway and cleanout. Included part of the roof since downspout drains here. Probably crack lateral

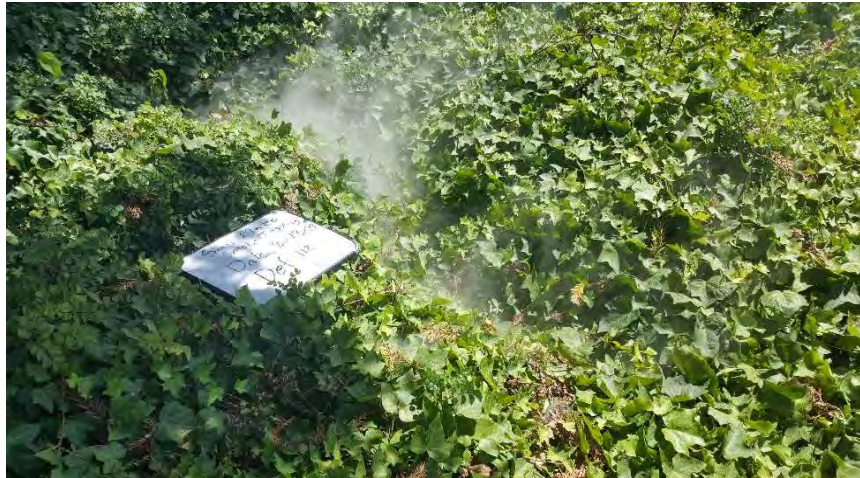
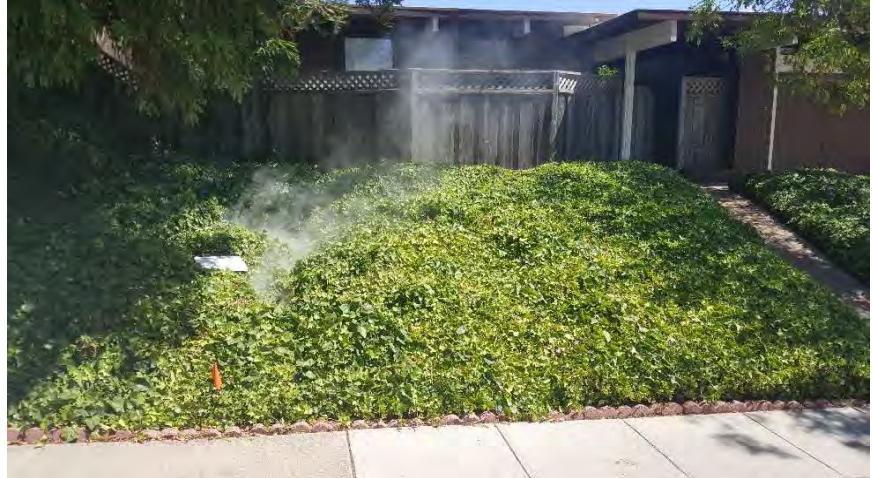
Project: San Mateo Smoke Testing 2019
Date: 8/13/2019
Defect: 112

Comments: 112: Most likely a lateral

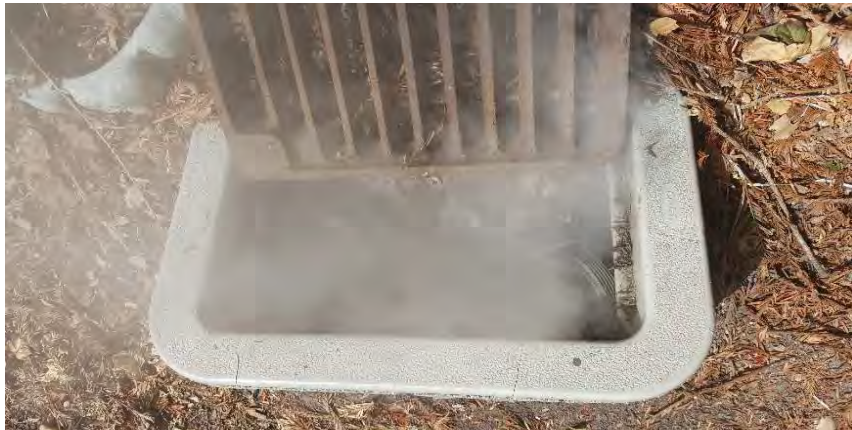
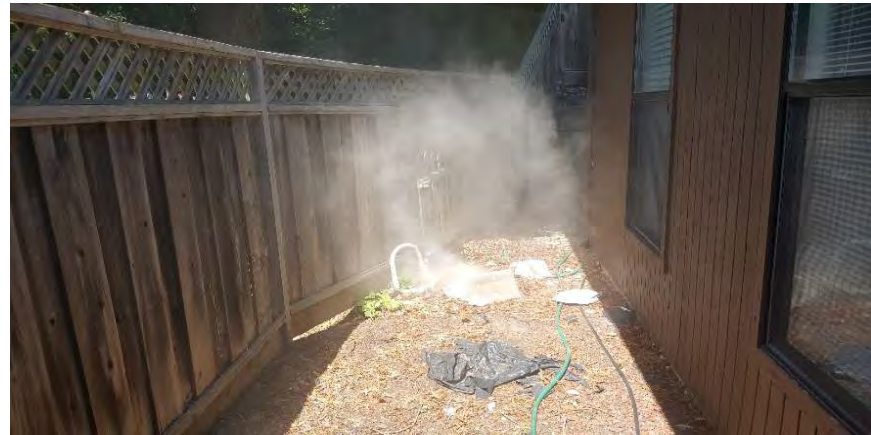
Project: San Mateo Smoke Testing 2019
Date: 8/13/2019
Defect: 113

113: Grated cleanouts with caps off

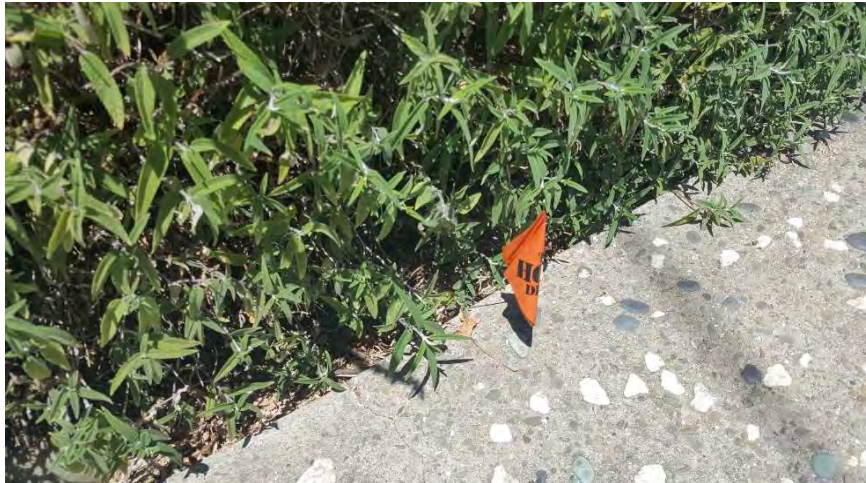
Project: San Mateo Smoke Testing 2019
Date: 8/13/2019
Defect: 121

Defect #	Address/Location	Results	Status	Source Type	Smoke	Area		Run Off	Photo #
						FT	FT		
121	1951 Ticonderoga Dr	1	1	1	1	4'	12'	3
