MEMORANDUM

DATE: January 19, 2024
TO: Mark Chow, County of San Mateo
FROM: Ben Shick, PE
SUBJECT: Crystal Springs County Sanitation District – Pipe
and Manhole Assessment and Recommendations

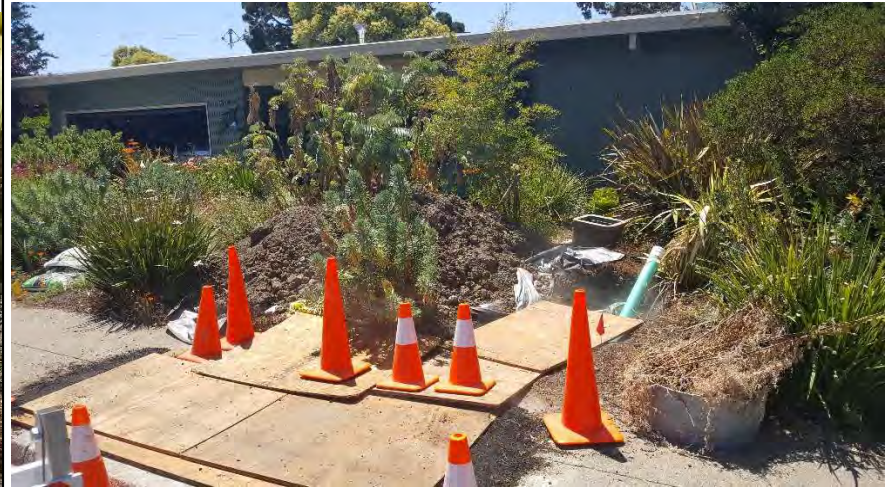
Project: San Mateo Smoke Testing 2019
Date: 8/13/2019
Defect: 122

Defect #	Address/Location	Results	Status	Source Type	Smoke	Area		Run Off	Photo #
						FT	FT		
122	1956 Lexington Ave	1	1	1	3	8'	10'	1

Comments: Work being done to lateral line

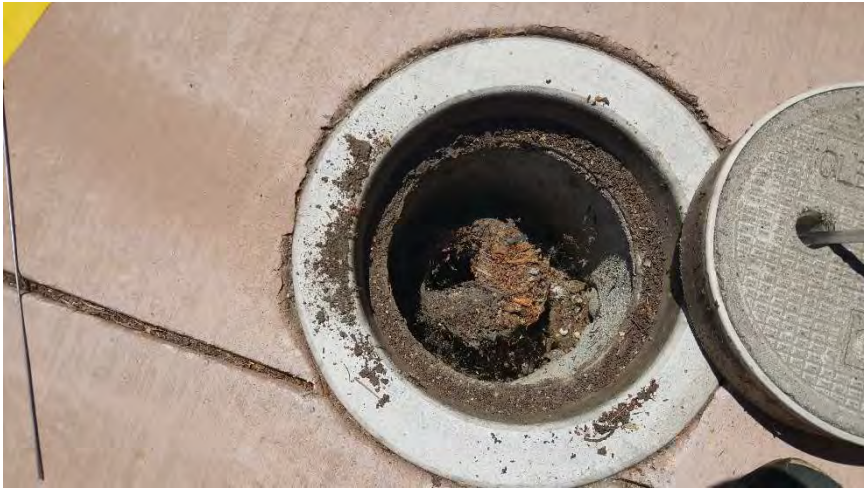
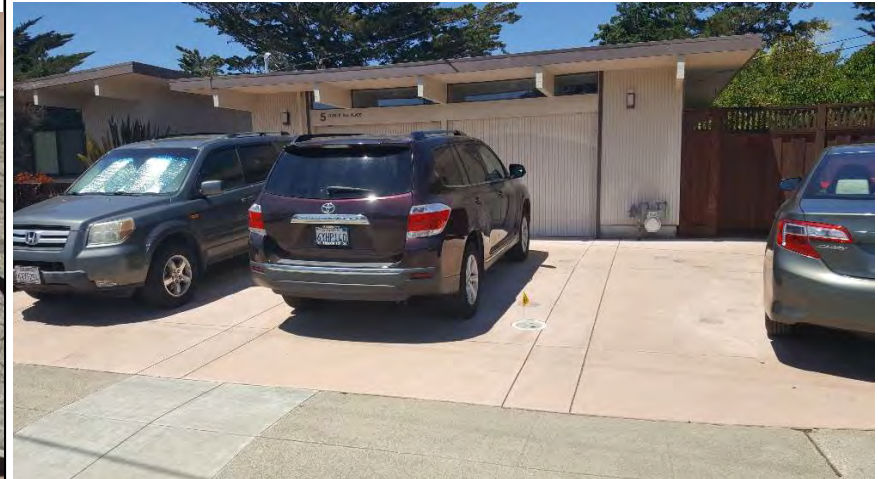
Project: San Mateo Smoke Testing 2019
Date: 8/13/2019
Defect: 123

Defect #	Address/Location	Results	Status	Source Type	Smoke	Area		Run Off	Photo #
						FT	FT		
123	5 Turtle Bay Pl	1	1	16	1	4"	4"	5

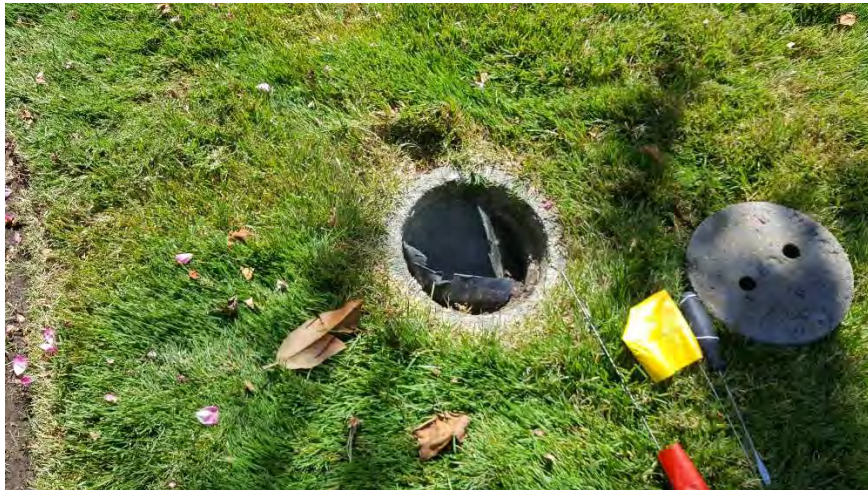
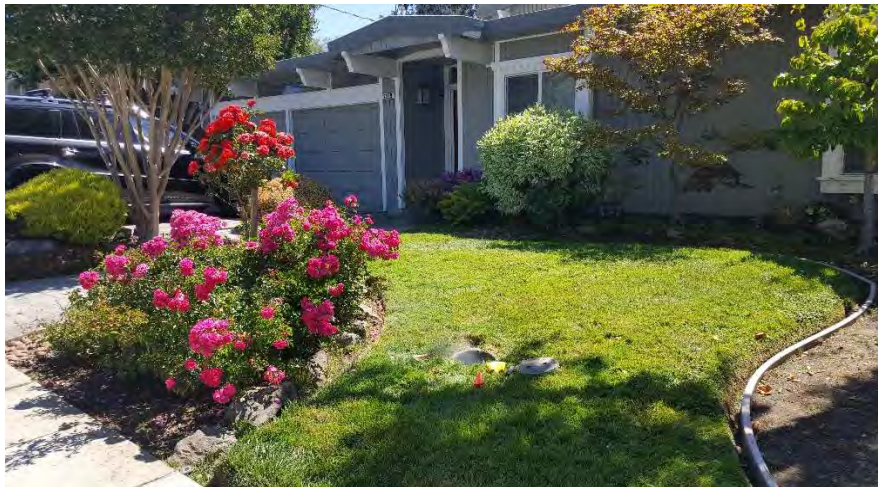
Project: San Mateo Smoke Testing 2019
Date: 8/14/2019
Defect: 143

Comments: No cap. Flows funnel here. Damaged pipe?

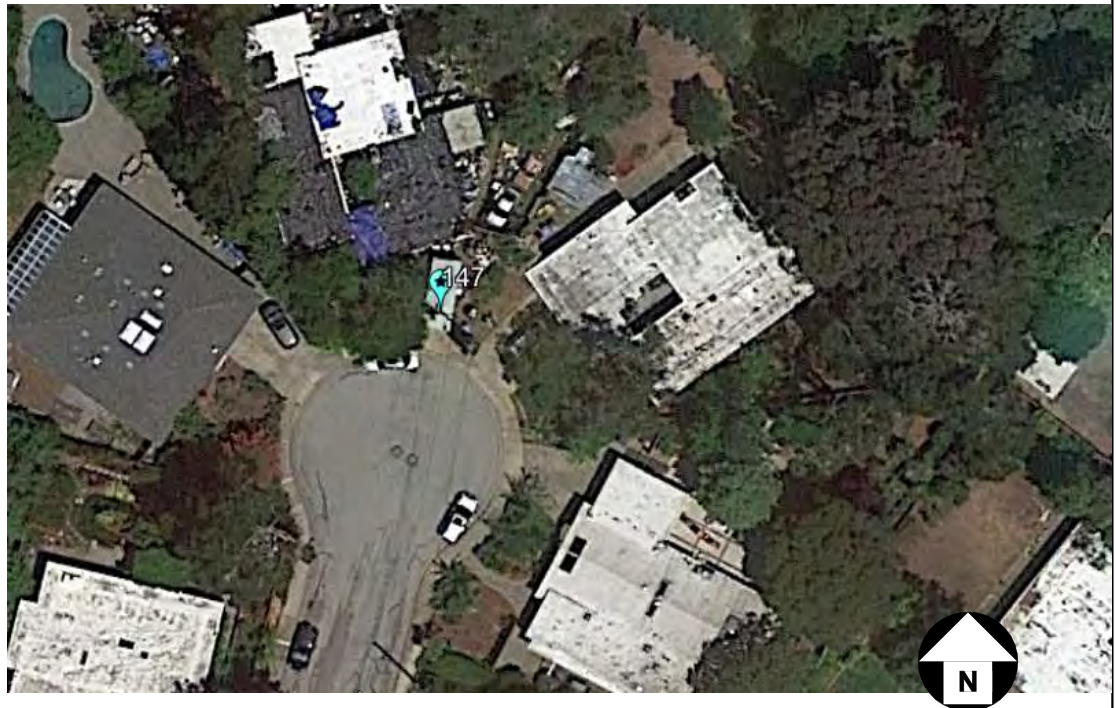
Defect #	Address/Location	Results	Status	Source Type	Smoke	Area		Run Off	Photo #
						FT	FT		
147	25 Amboy Ct	1	1	17	2	8'	12'	5

Comments: Could not tell source. Under container car

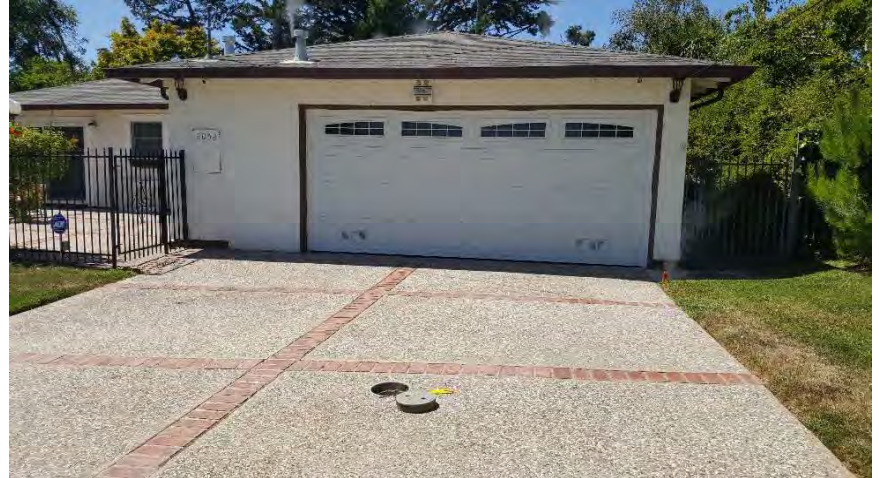
Project: San Mateo Smoke Testing 2019
Date: 8/14/2019
Defect: 150

Comments: 150: Rusty/ deteriorated cap

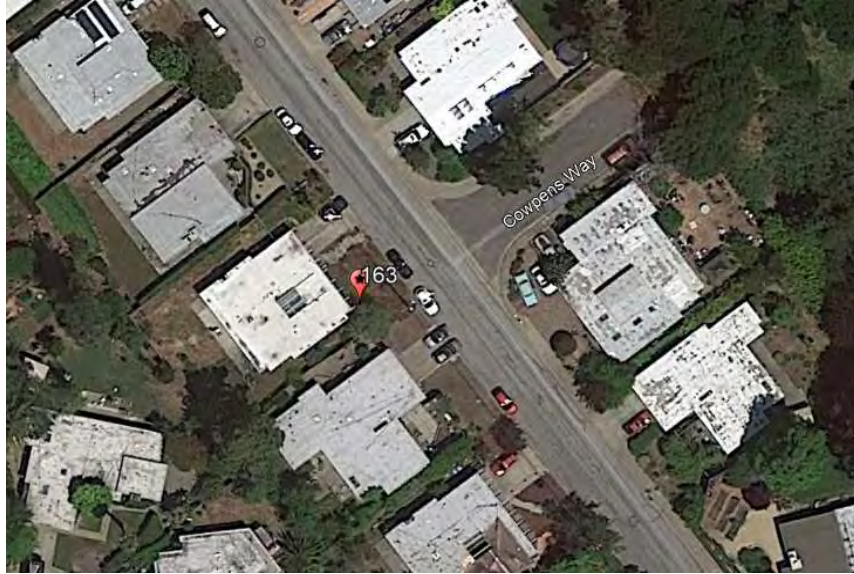
Project: San Mateo Smoke Testing 2019
Date: 8/14/2019
Defect: 162

Comments: No cap. Downspout drains here

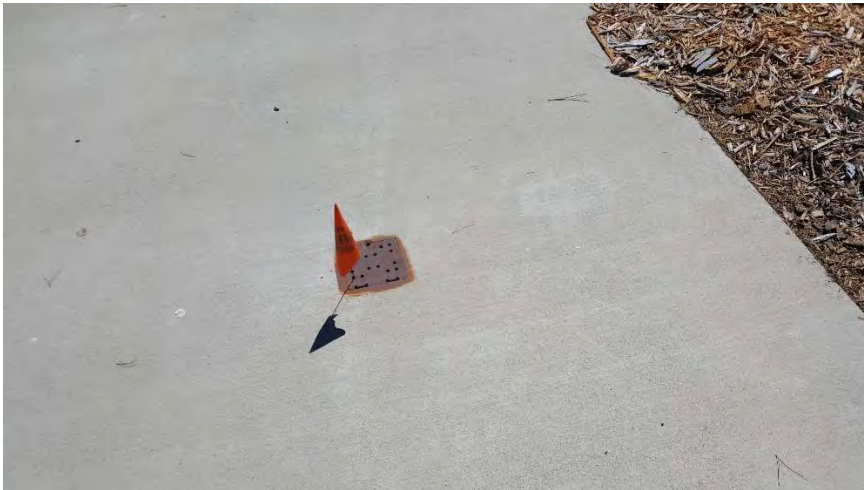
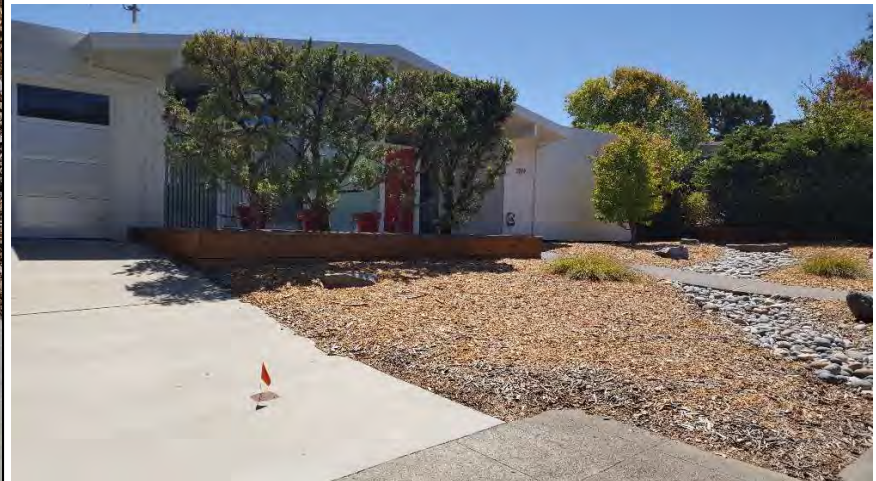
Project: San Mateo Smoke Testing 2019
Date: 8/14/2019
Defect: 165

Comments: Cap loose. Water flows over top.
